ADDENDUM NO. 1

Project: **Project #:** 0415-468-1
California Roof Replacement Bldg 1 & 3A (2023)

**HAZARDOUS MATERIALS SURVEY
FINAL REPORT**

**California Middle School
1600 Vallejo Way
Sacramento, CA 95818**

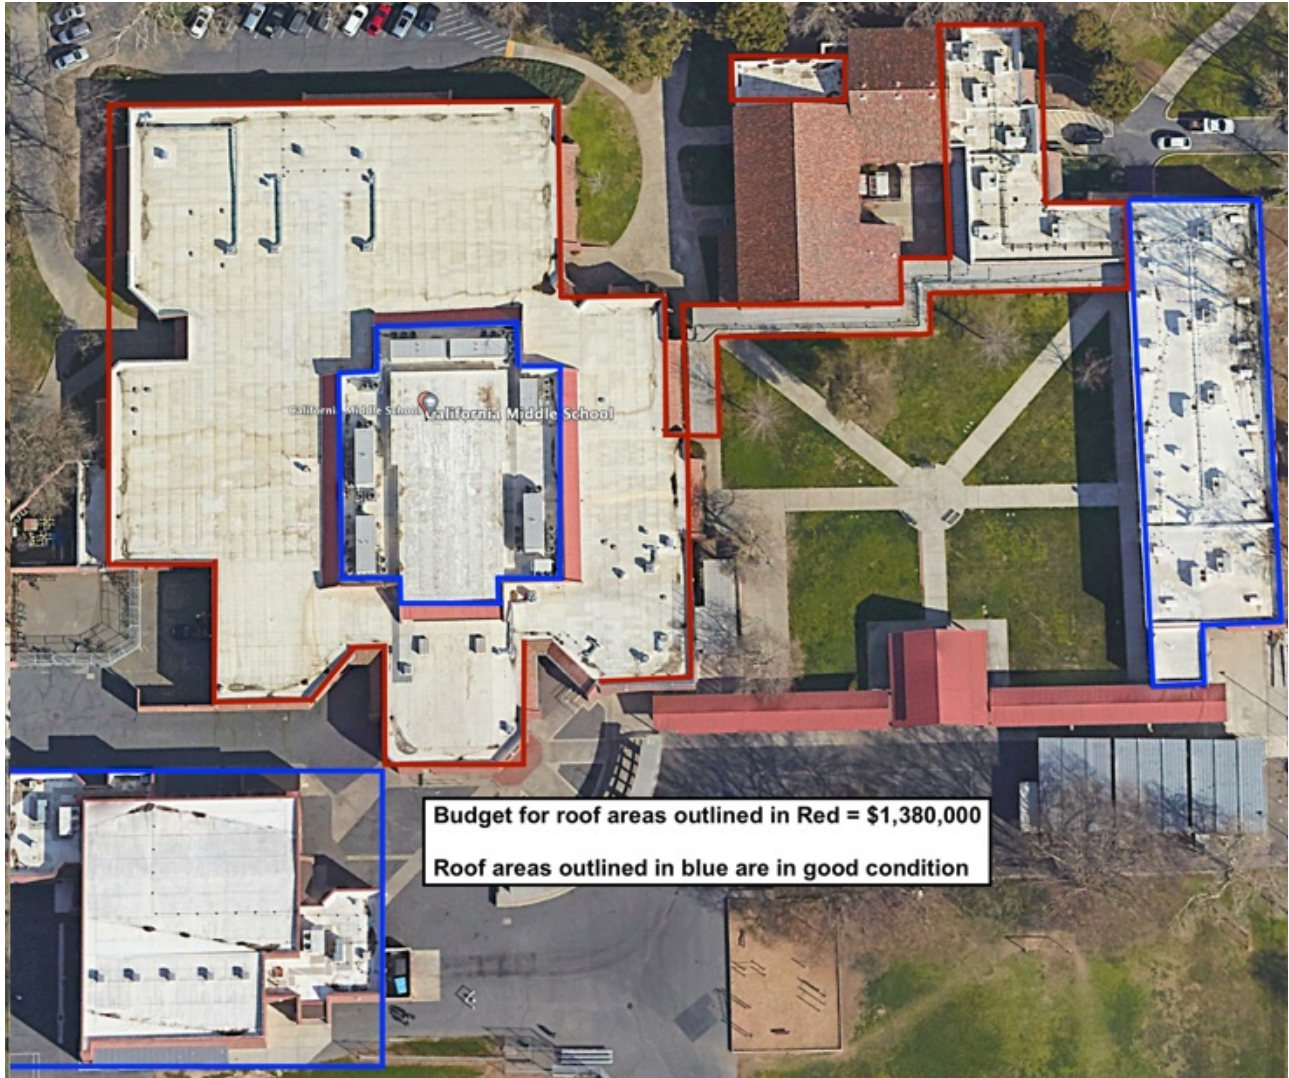
On March 2, 2023 Entek conducted a survey specific to areas designated by the Owner's representative which included roofing materials as designated by red outlines in the following drawing.

The results of testing for asbestos during this survey indicate asbestos is not present in any of the sampled roofing or associated materials. Specifics pertaining to individual materials can be found in later sections of this report.

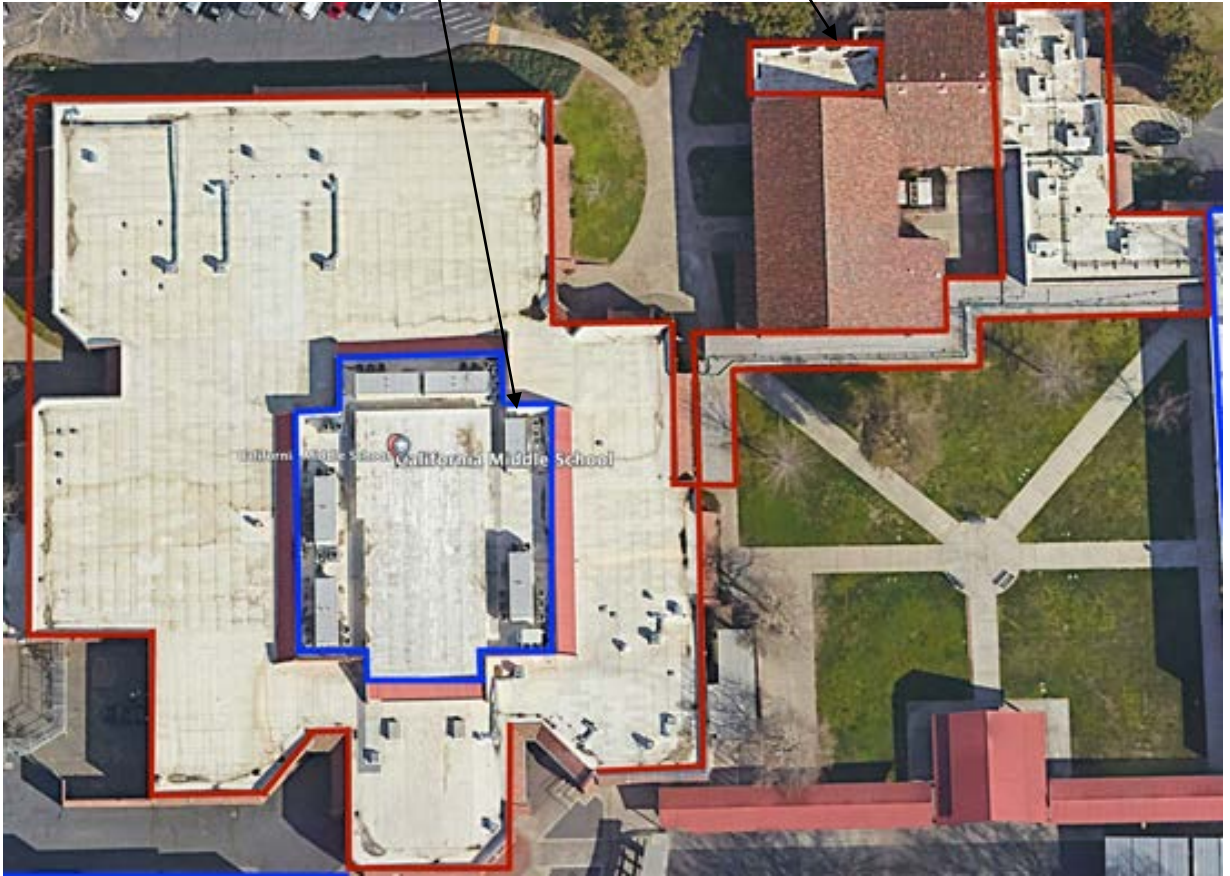
Entek investigated existing paints and applied coatings in an effort to determine if lead was present in these materials. None of the counterflashing paints expected to be impacted as part of this project were found to have detectable levels of lead. Specifics pertaining to individual materials can be found in later sections of this report.

01Pb

02Pb

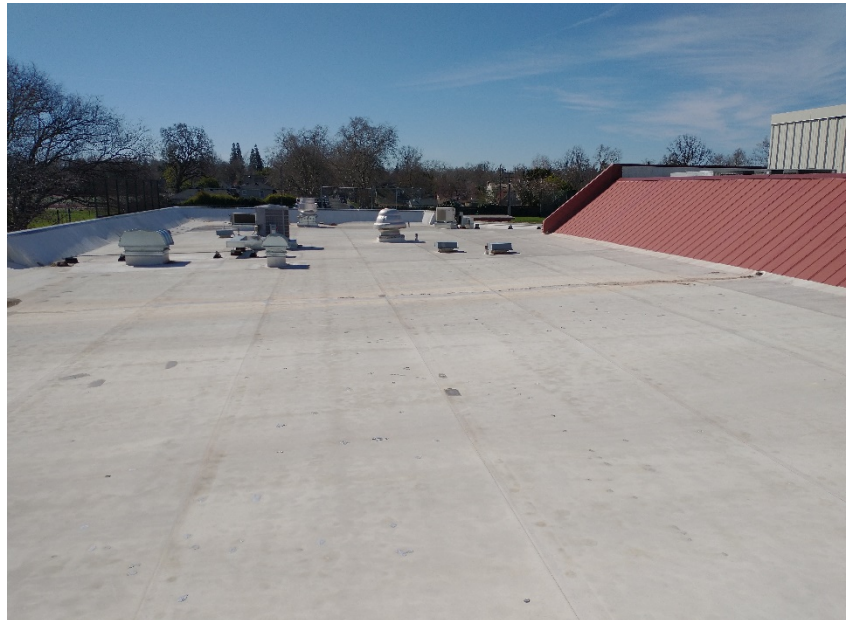
Main Building Single Ply Membrane Roofing

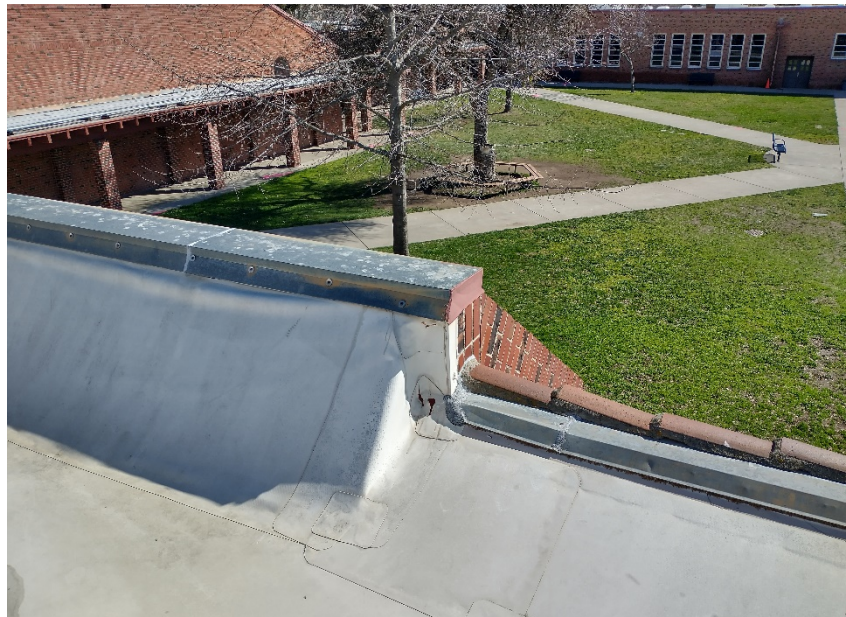
Main Building Parapet Wall with Flashing and Clay Roofing Tile Adjacent

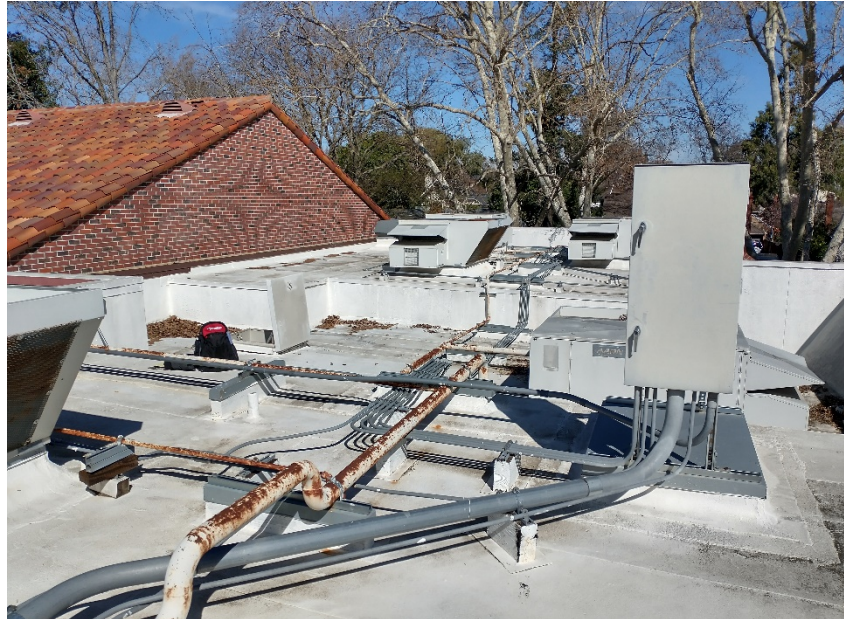
East Building with Asphaltic Roofing

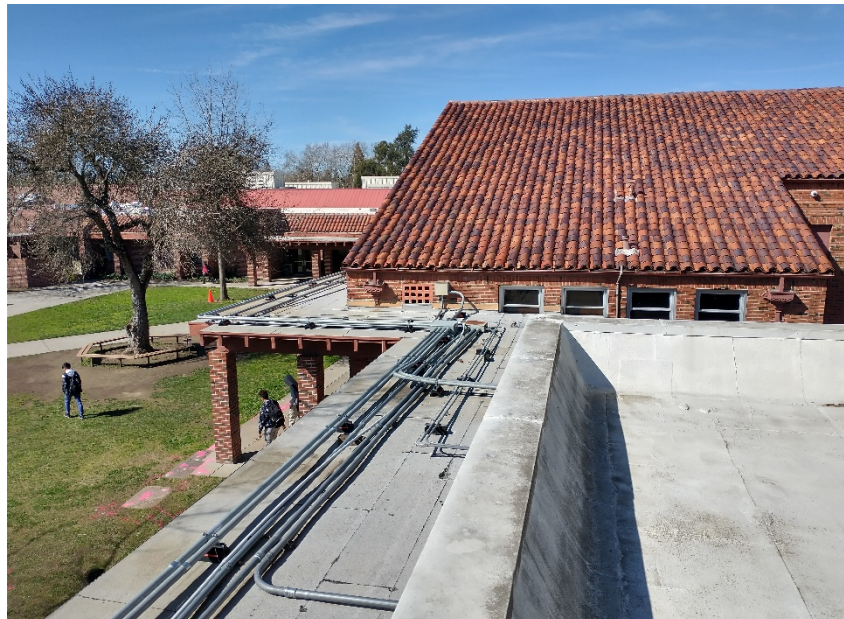
East Building Covered Walkways with Asphaltic Roofing

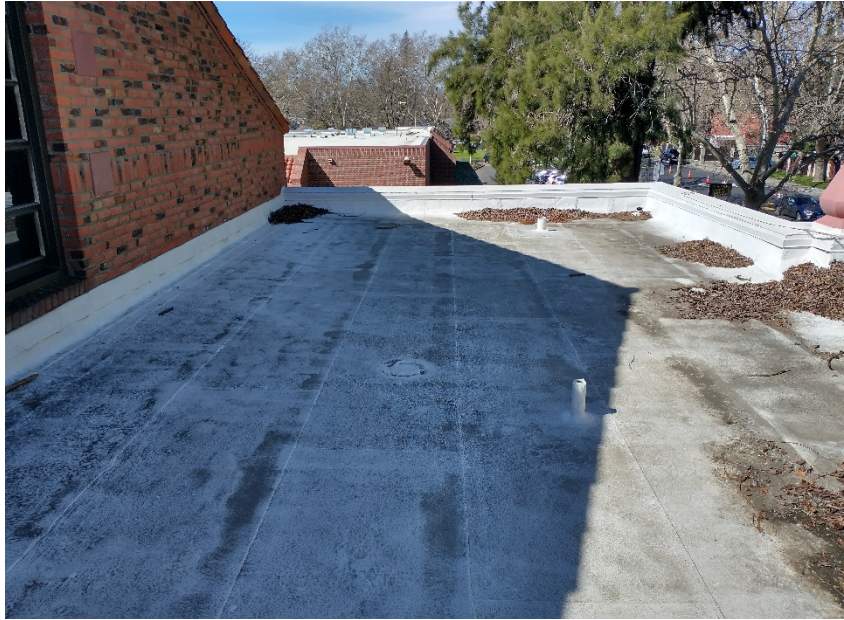
East Building North Side with Asphaltic Roofing

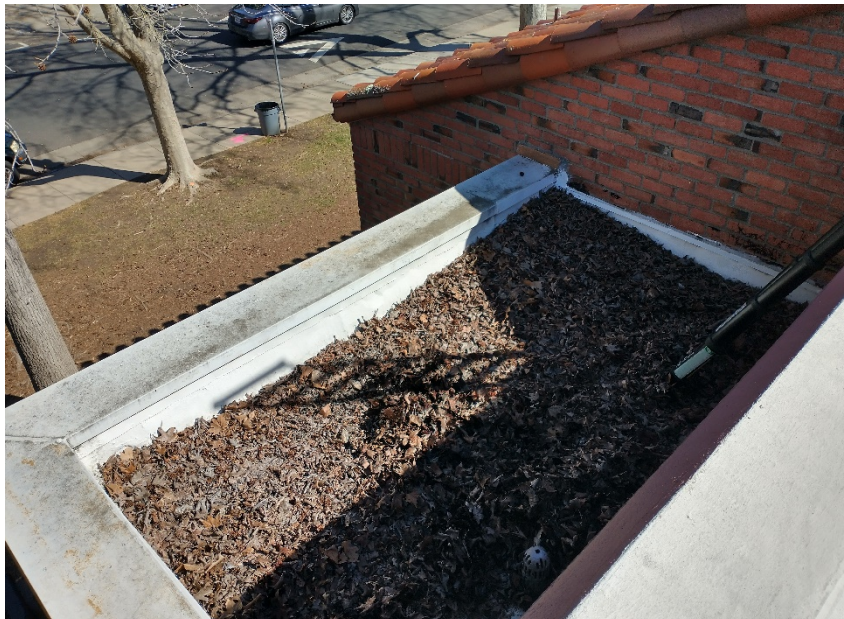
East Building North Side Lower Roof with Asphaltic Roofing
