**HAZARDOUS MATERIALS SURVEY  
FINAL REPORT**

**Sequoia Elementary School  
3333 Rosemont Drive  
Sacramento, CA 95826**

**South Toilet Building, Site Fencing, Site Exterior Paints  
Toilet Building Demolition, Fencing & Painting Project**

**Entek Project #23-6616**

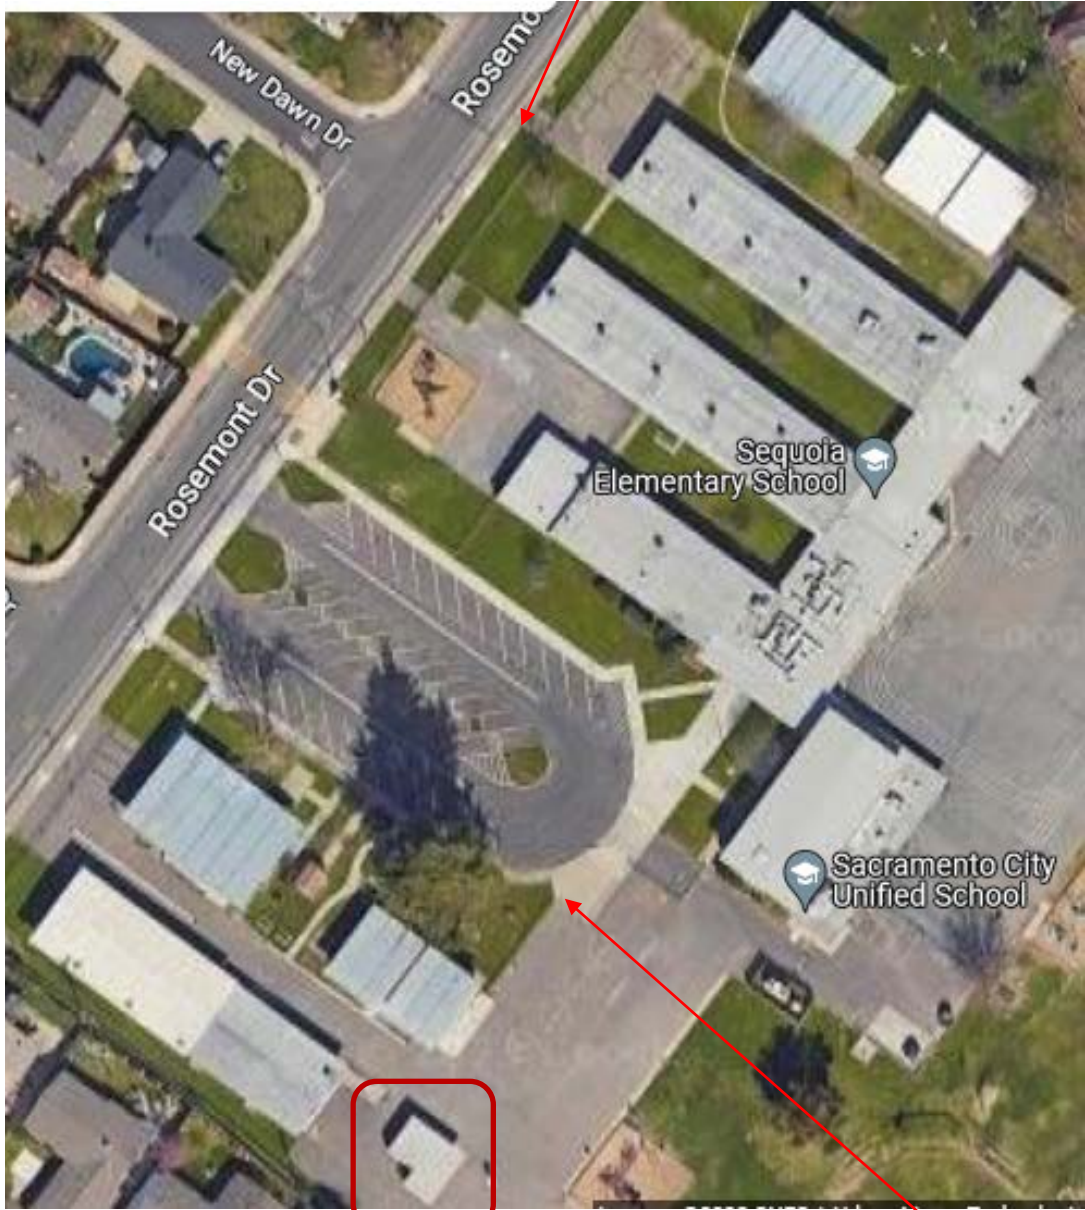
Toilet Building

12B(-)

12A(-)
