**HAZARDOUS MATERIALS SURVEY
FINAL REPORT**

**Albert Einstein Middle School
9325 Mirandy Drive
Sacramento, CA 95826**

**Roofing (Excluding Gym Building), Exterior Windows & Paints
Re-Roof & Beautification Project**

Entek Project #23-6539

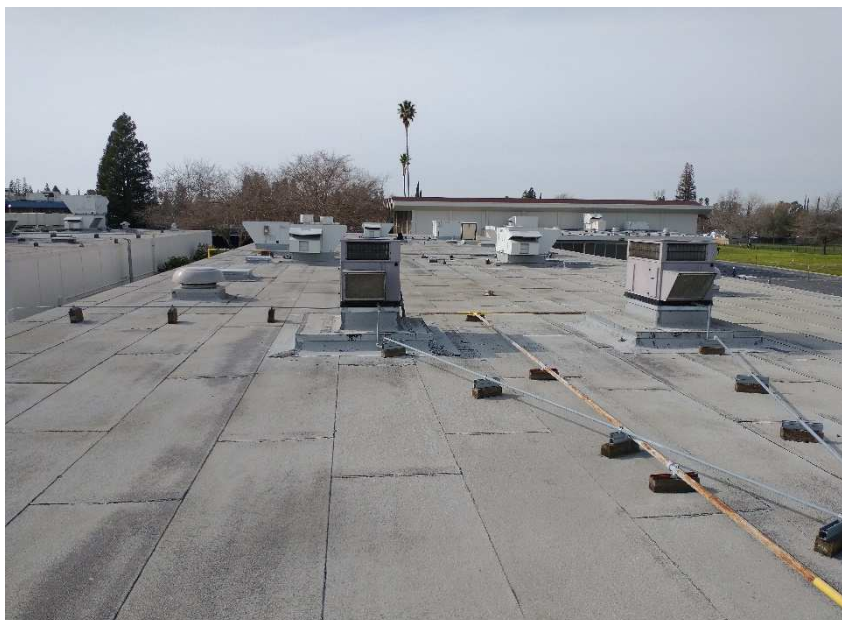
The results of testing for asbestos during this survey indicate asbestos is present in roof jack and curb mastic on the northeast classroom building and in the window glazing putty found on windows throughout campus. Specifics pertaining to individual materials can be found in later sections of this report.

Roof of Northeast Classroom Building Showing Roof Jacks and Curbs

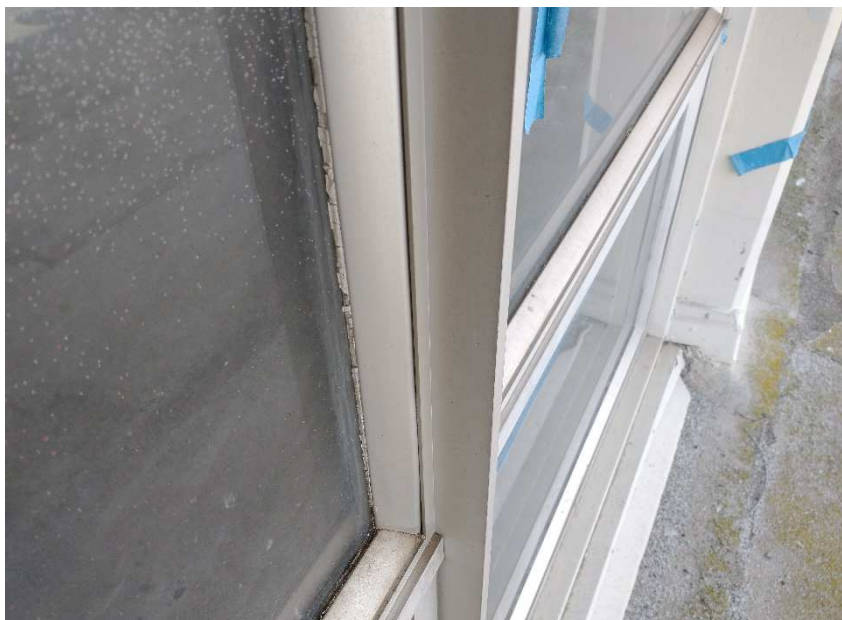
Window Frame Showing Glazing Putty
