**HAZARDOUS MATERIALS SURVEY
FINAL REPORT**

**Luther Burbank High School
3500 Florin Road
Sacramento, CA 95823**

**Classrooms B1-B6, C1-C6, D1-D6, E1-E6, F1-F6, & H1-H6
Flooring Replacement & Painting Project**

February 23, 2023

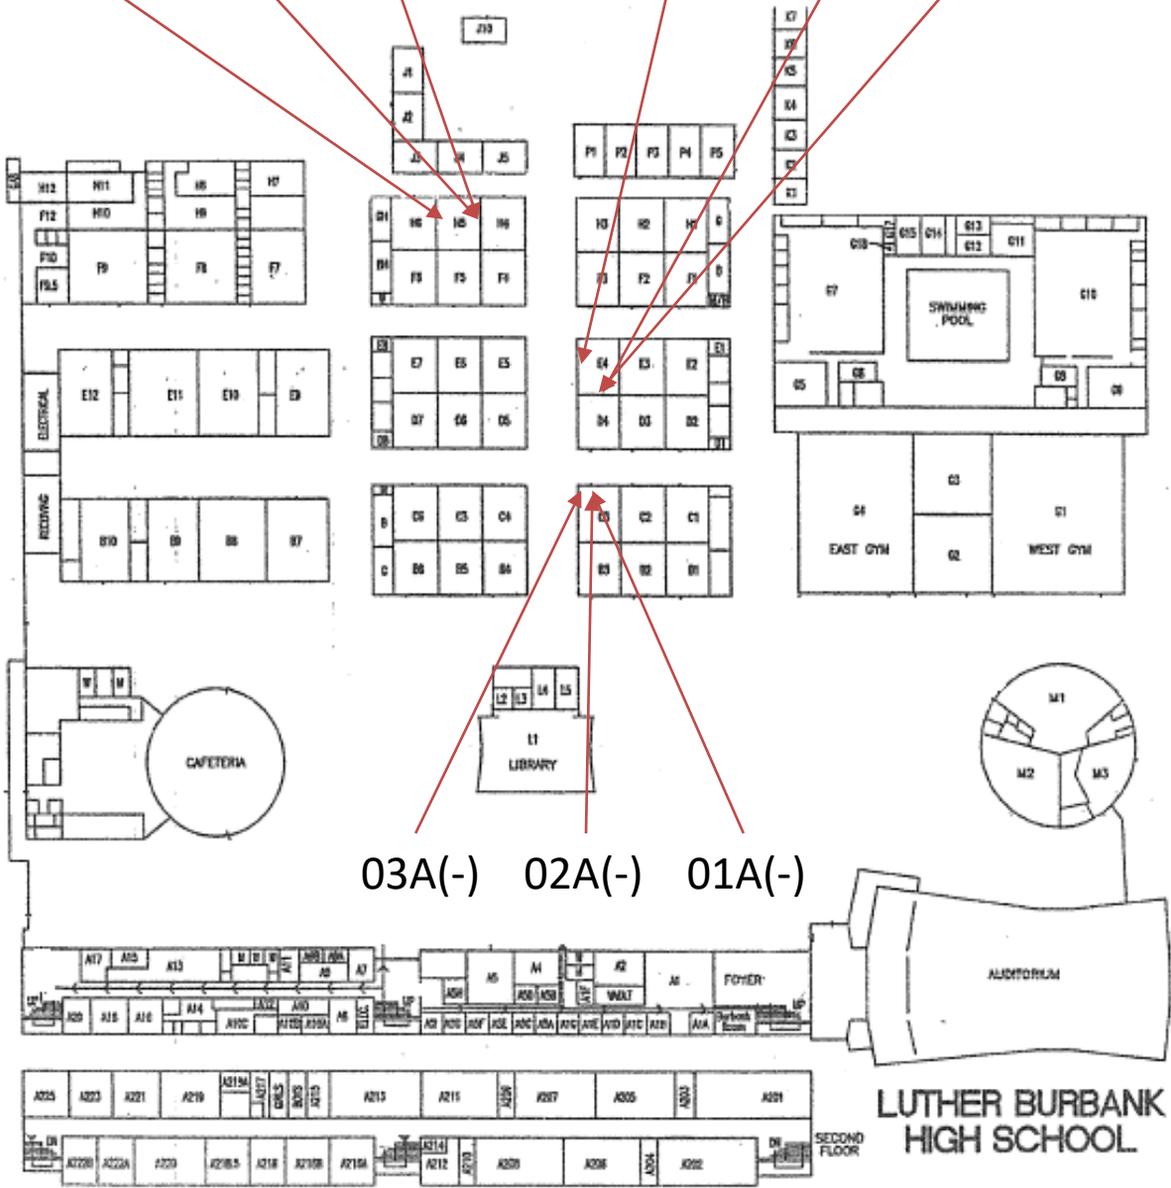
The results of testing for asbestos during this survey indicate asbestos is present in the hidden bottom layer of vinyl floor tile, the associated black floor mastic, and in brown cove base mastic throughout all classrooms. Specifics pertaining to individual materials can be found in later sections of this report.

03C(+) 02C(+) 01C(-) 03B(+) 02B(+) 01B(-)

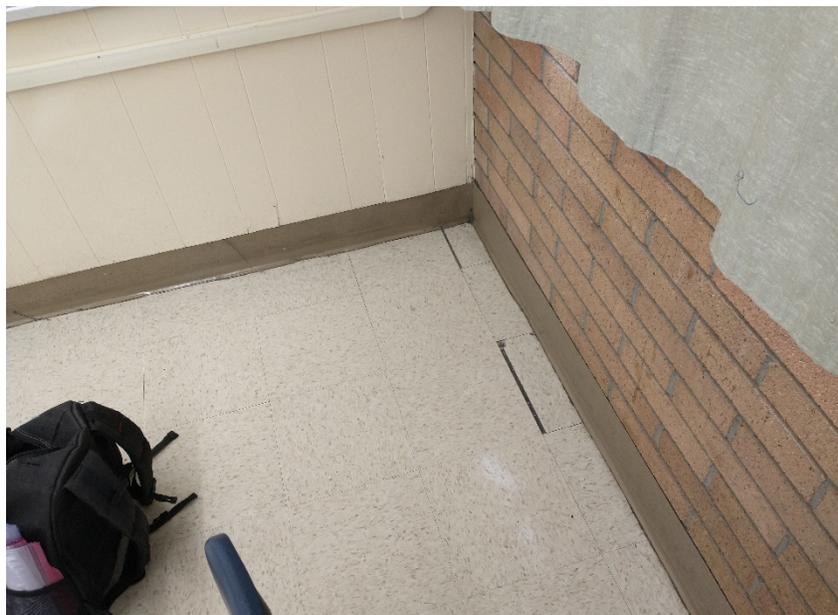
Typical Classroom Floor with Vinyl Floor Tile, Cove Base, Brick Wall, Wood Wall

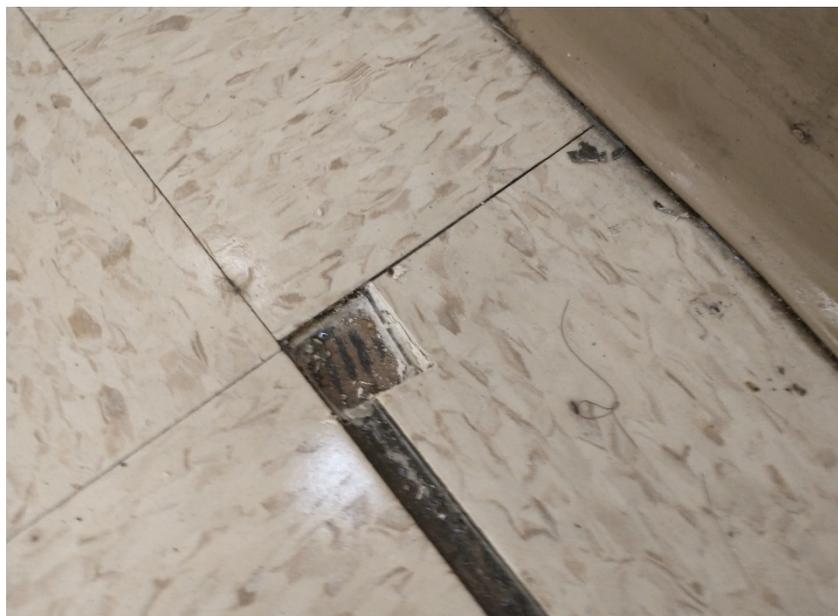
The classroom floors were found to have a top visible layer of 12" vinyl floor tile over a hidden bottom layer of vinyl floor tile.

Multiple Layers of Vinyl Floor Tile Assumed Present in All Classrooms

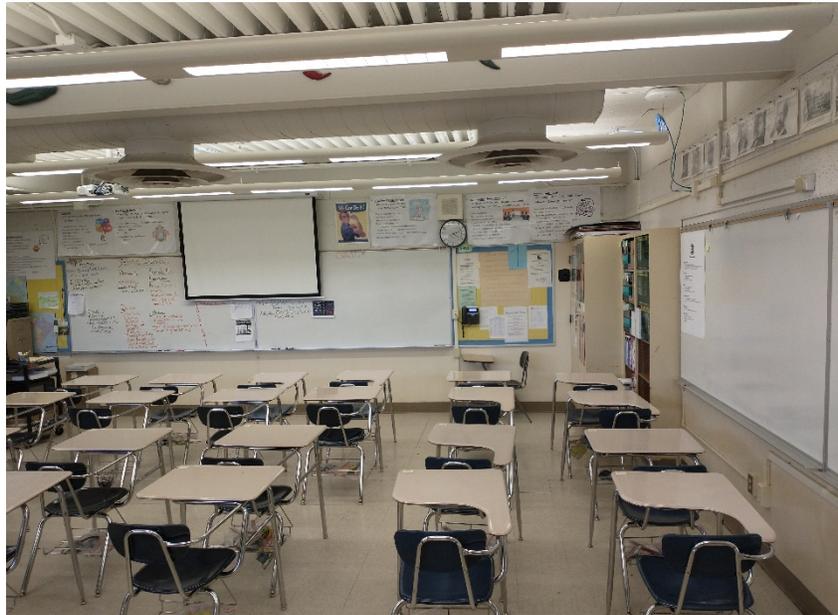
Typical Classroom Layout

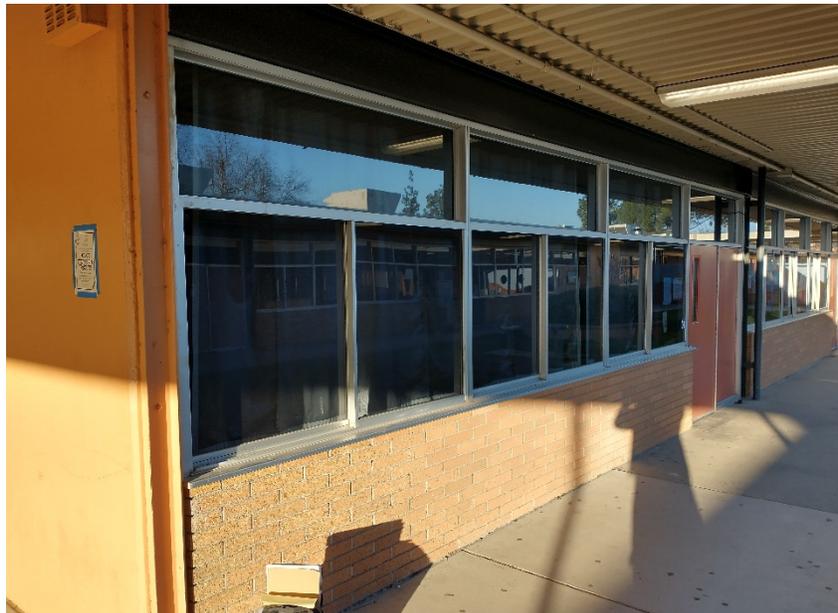
Typical Exterior of Classrooms

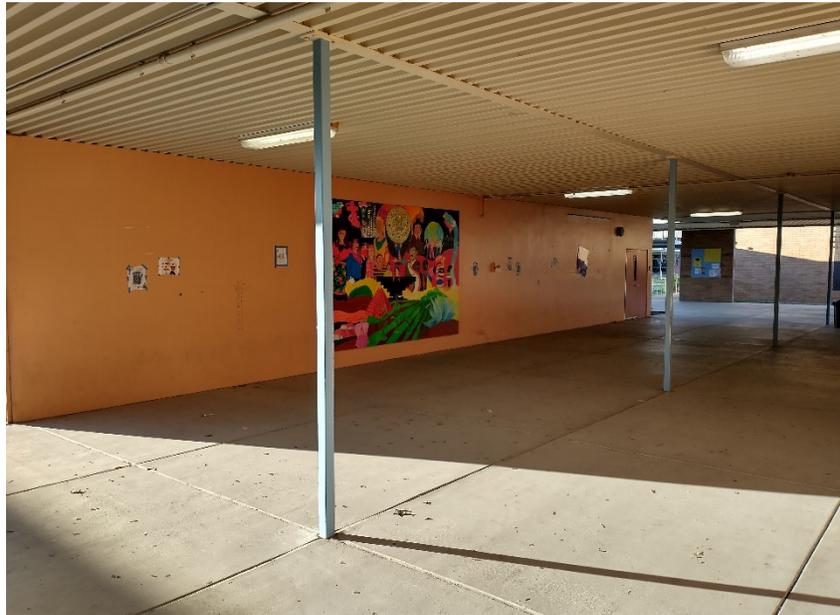
Typical Hallway Near Classrooms

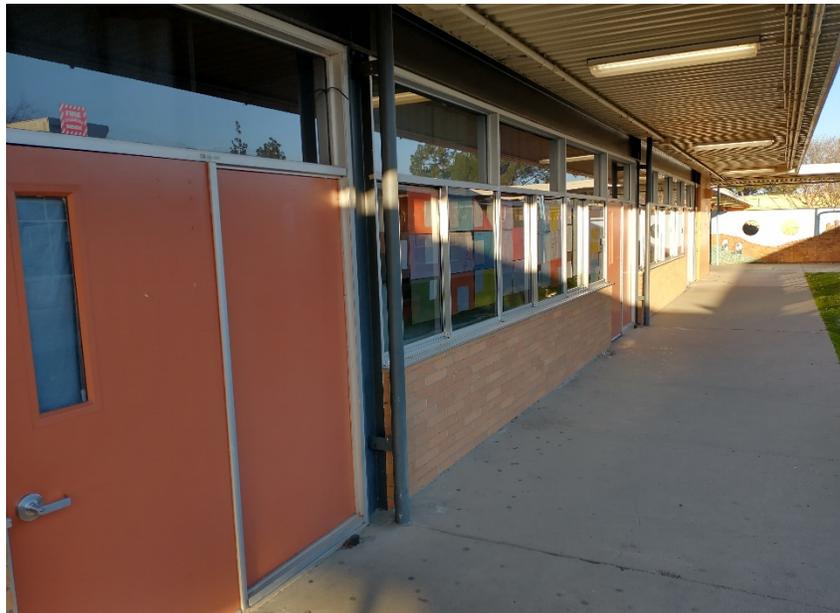
- Blue colored paint - Metal support columns associated with overhangs and covered walkways near all classrooms

Typical Covered Walkways Outside Classrooms
