ADDENDUM NO. 1

Project: 0570-409, American Legion Roof Replacement

**Asbestos Building
Inspection/Survey**

**American Legion High School
Roofs**

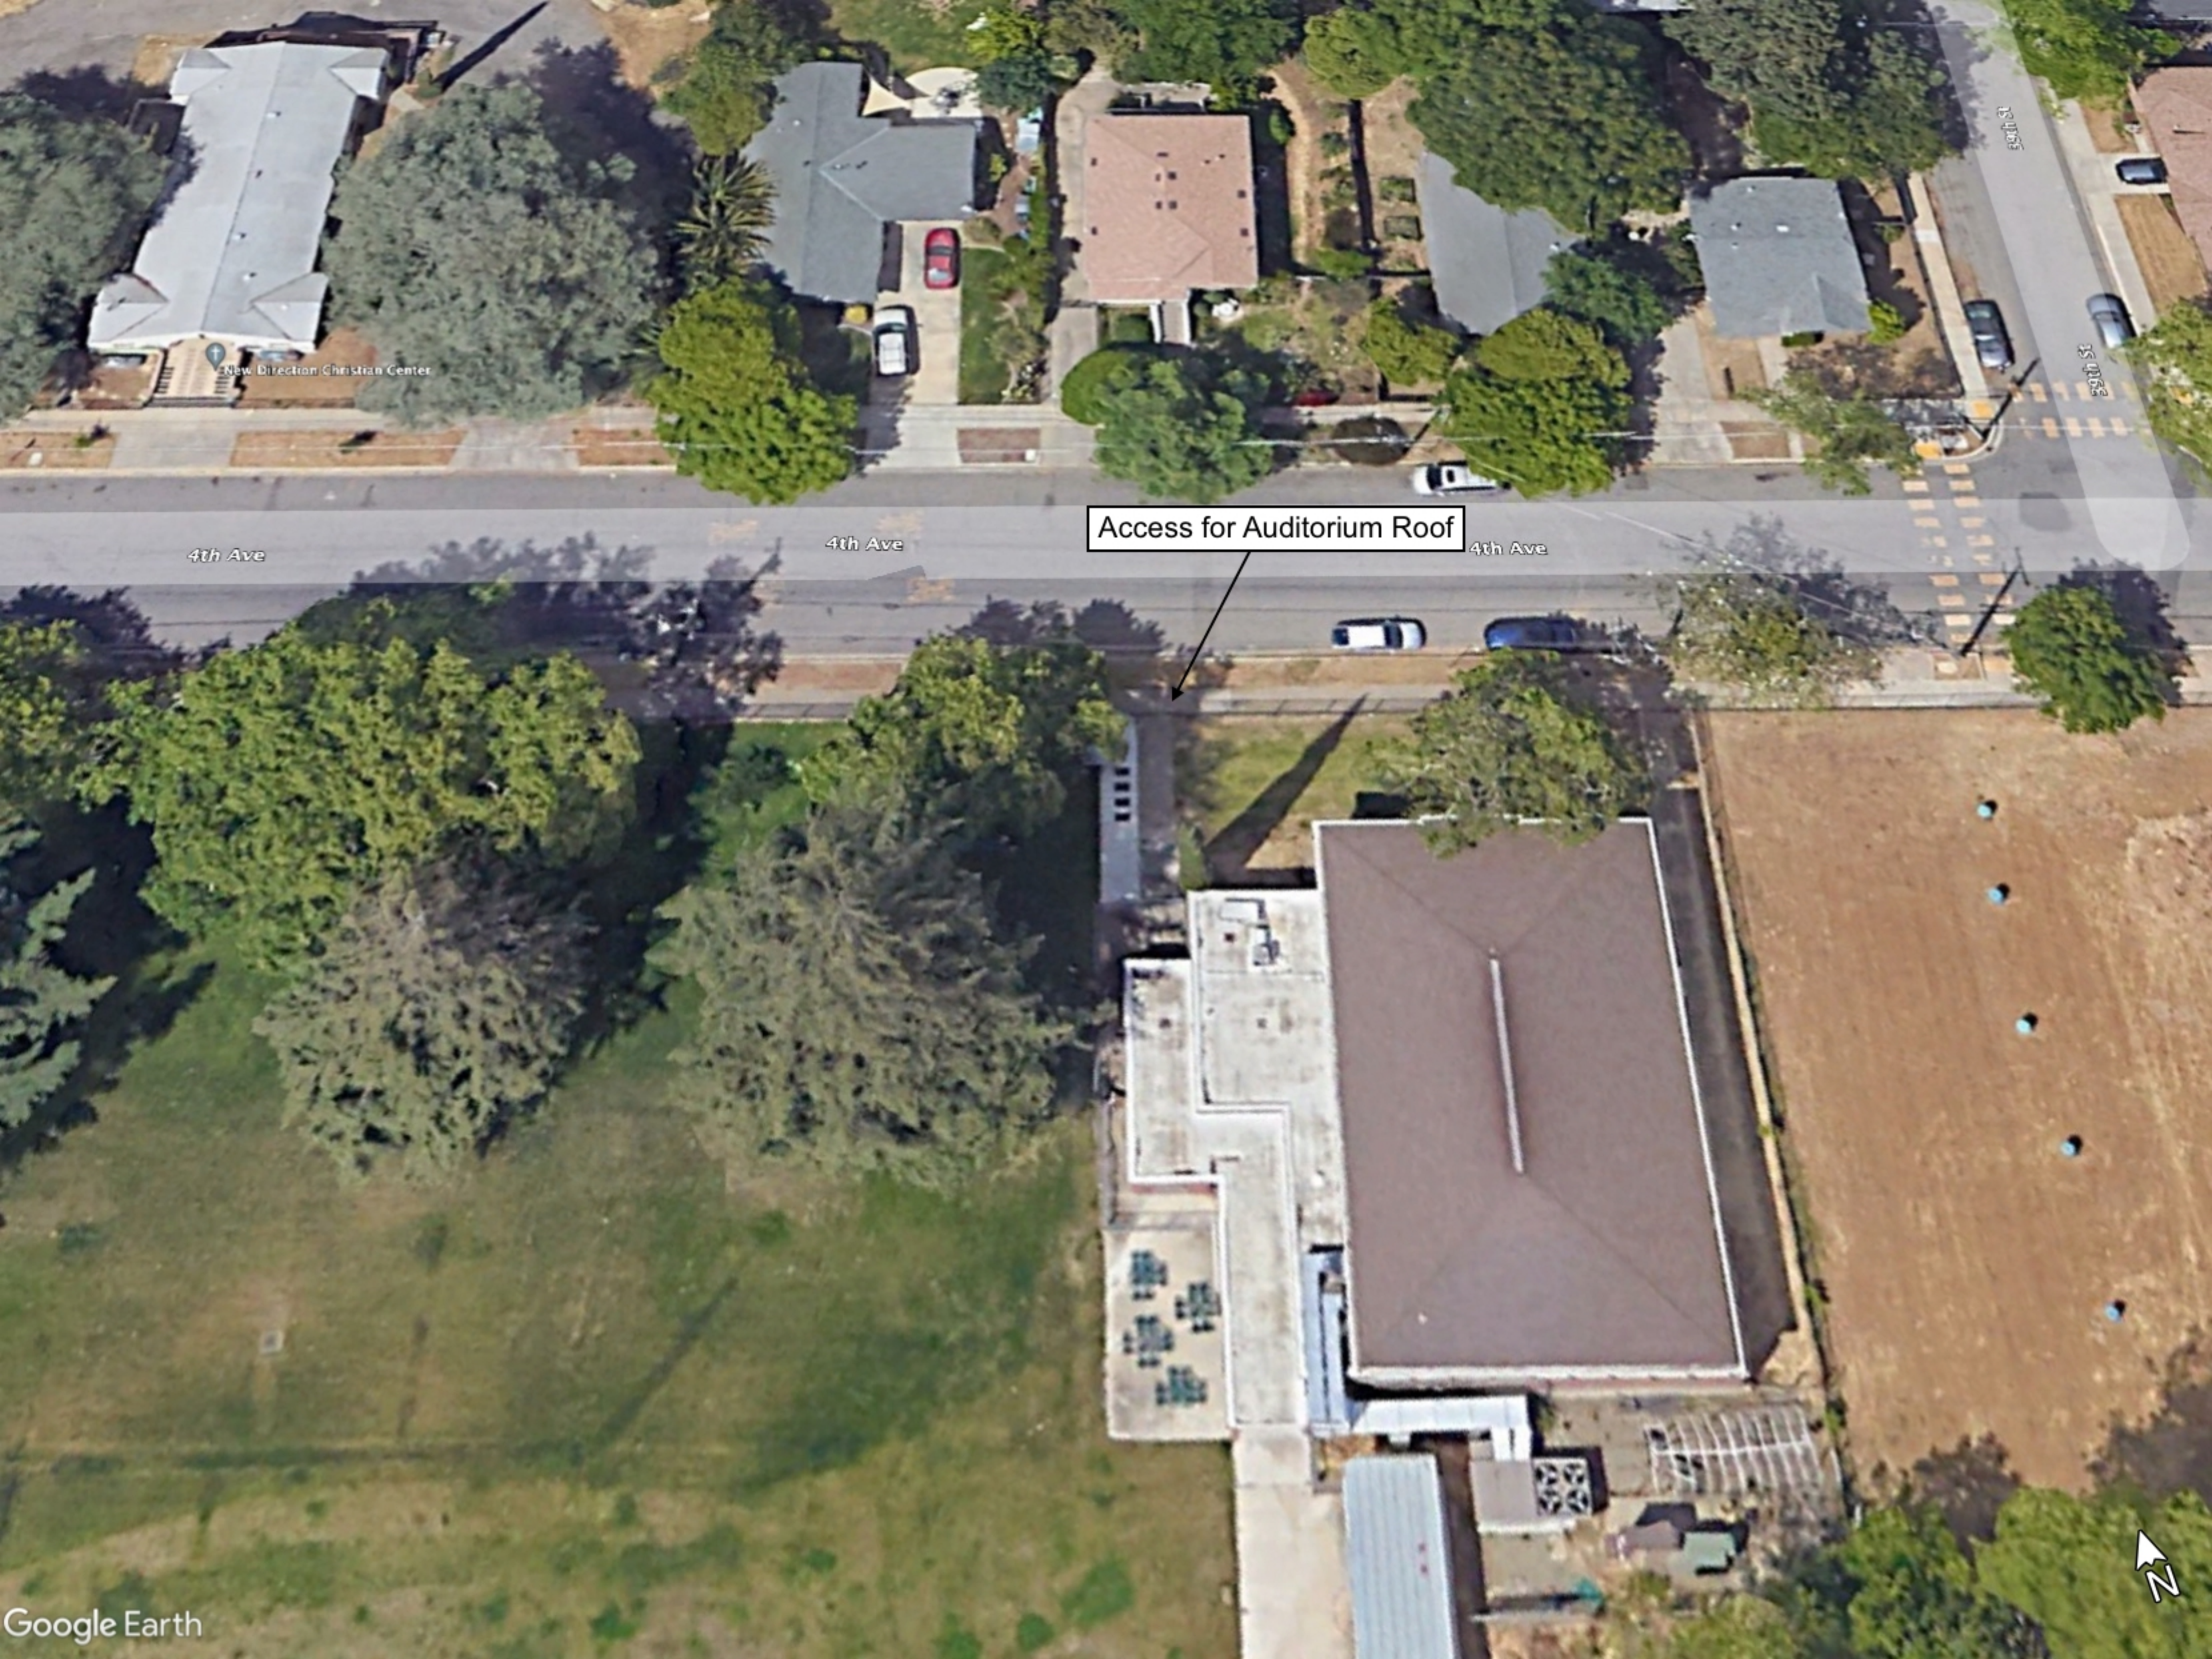
Access for Auditorium Roof

1. Access to the Auditorium roofs will require removal of two sections of metal fencing on the north side of the campus (see attached picture). Contractor will be responsible for temporarily securing the removed fence area while on the Auditorium roof and reinstalling the fencing upon completion.
2. Protection and or repair of existing curb, sidewalk, landscape and irrigation will be required.

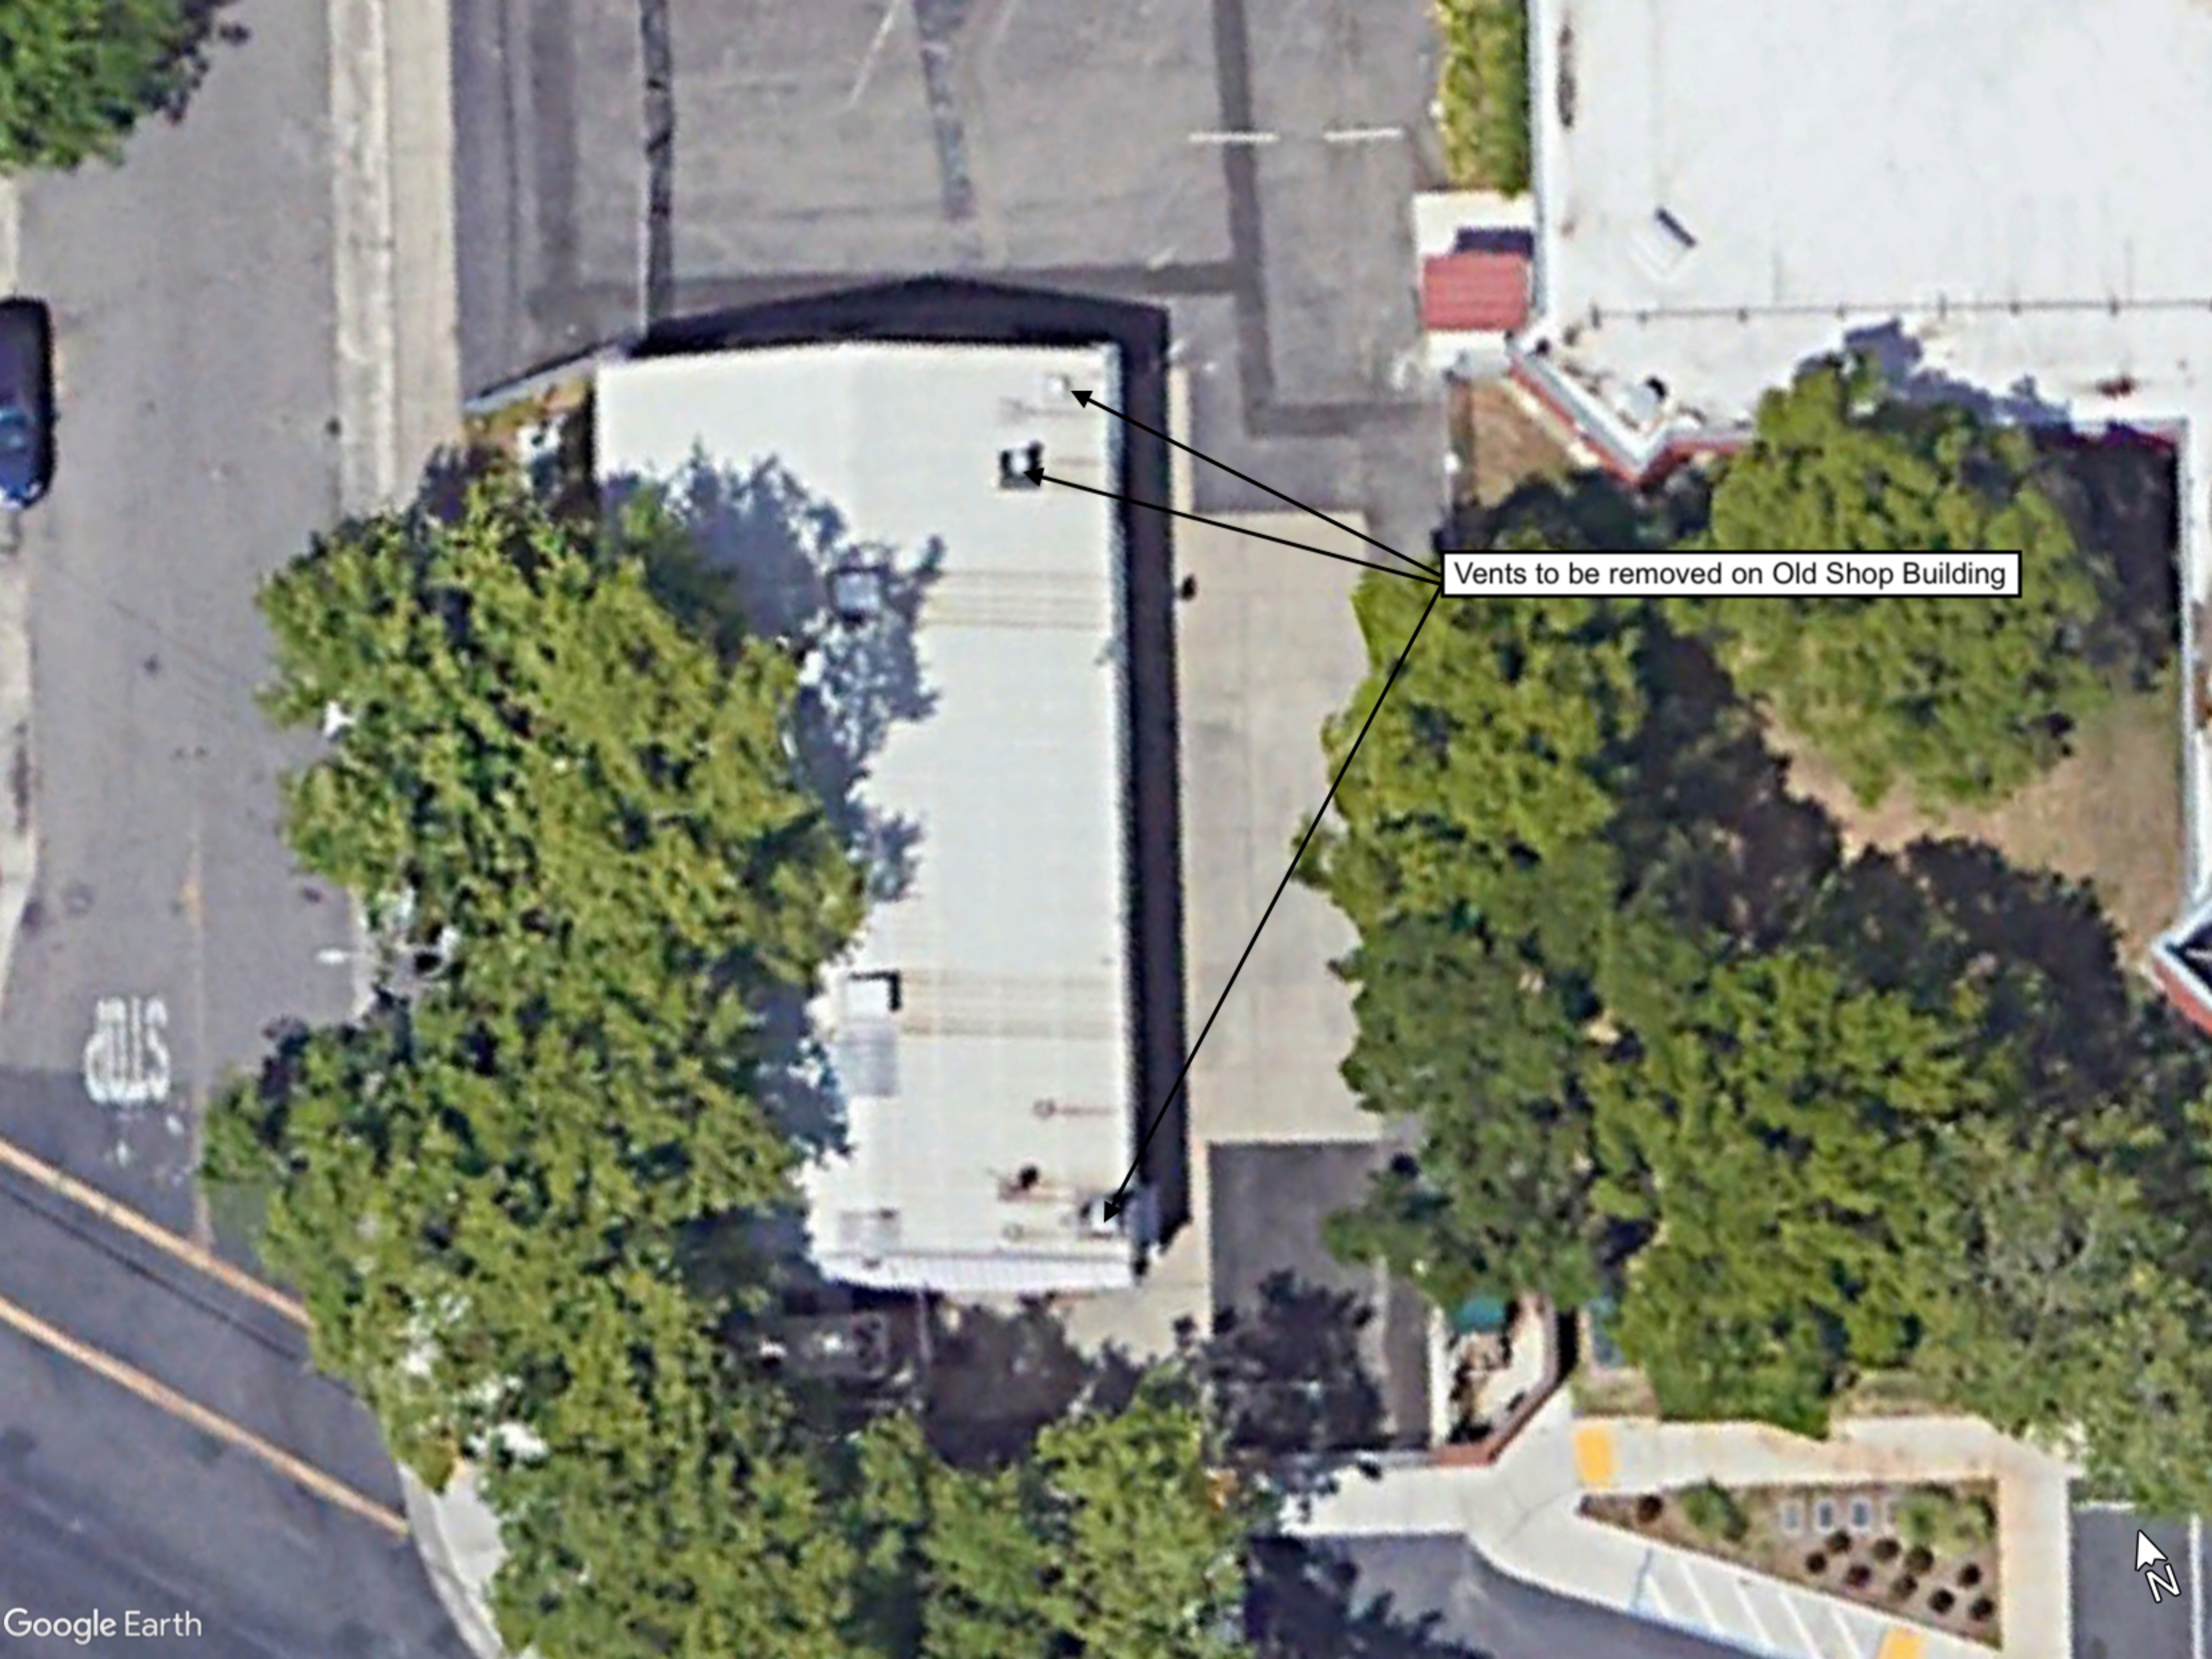
Vents to be removed on Old Shop Building

1. Remove 3 abandoned vent penetrations minimum 6" below underside of roof (see attached picture for reference). Install new panels at these locations to match existing size and profile.
2. Lower shed roof on East side to be included in scope.
