Sacramento City Unified School District

ALICE BIRNEY WALDORF-INSPIRED K-8 SCHOOL

HIGH PERFORMANCE FACILITY ASSESSMENT

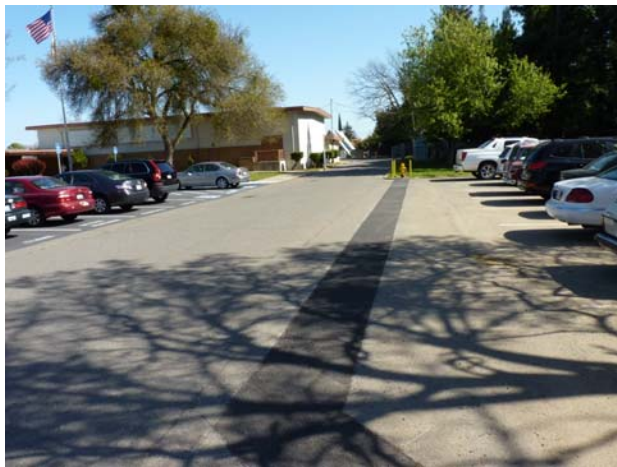
**Sustainable Sites School Entry/Drop Off**  
*Safety concerns - not enough lane length, so parents drop off students on street.*

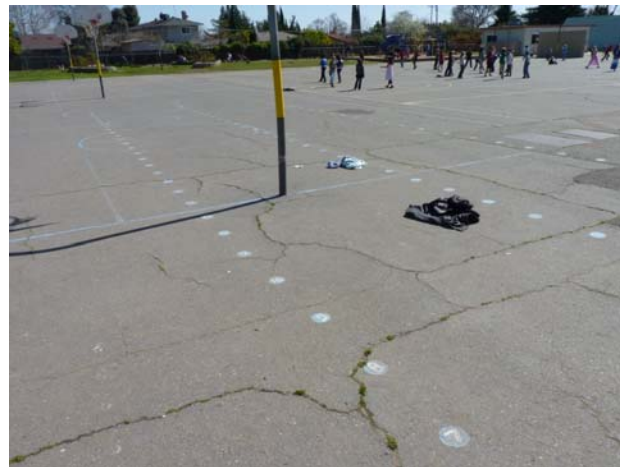
**Sustainable Sites Outdoor Activity**  
*Play surface is uneven and cracking, needs repair, slurry seal and re-striping.*

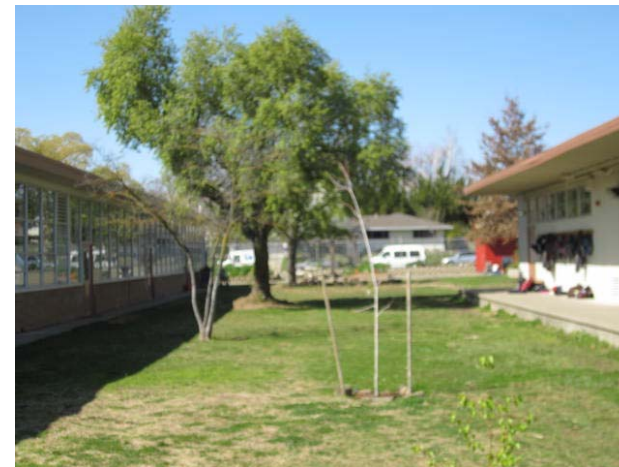
**Sustainable Sites Campus Core**  
*Shade is inadequate, more trees could create outdoor learning opportunities.*

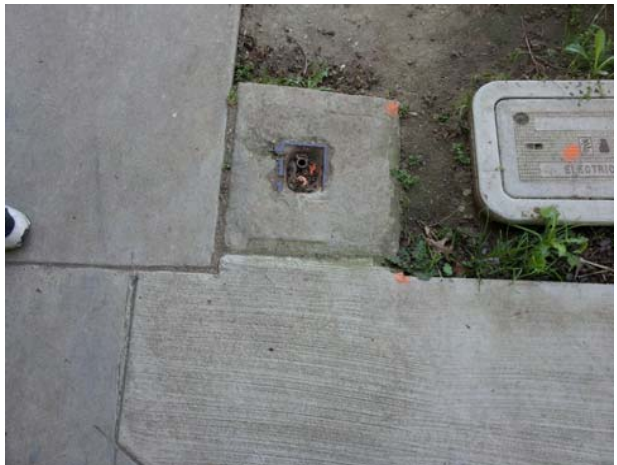
**Water Efficiency Exterior**  
*Existing hose bib is at grade, filled with dirt and should not be used without back flow prevention.*

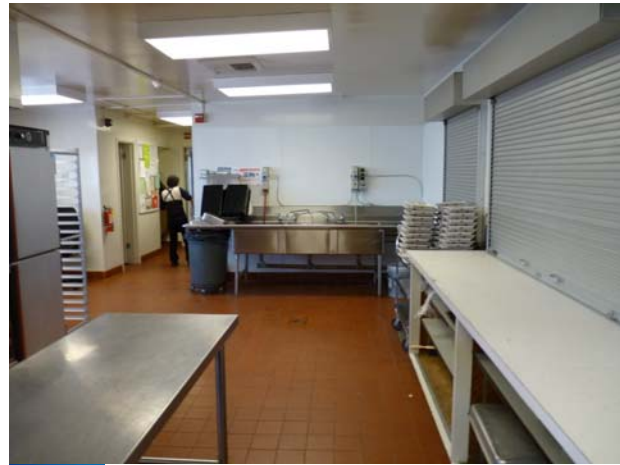
**Water Efficiency Interior**  
*Waste from the food wash sink has a direct sewer connection. This should have indirect connection.*

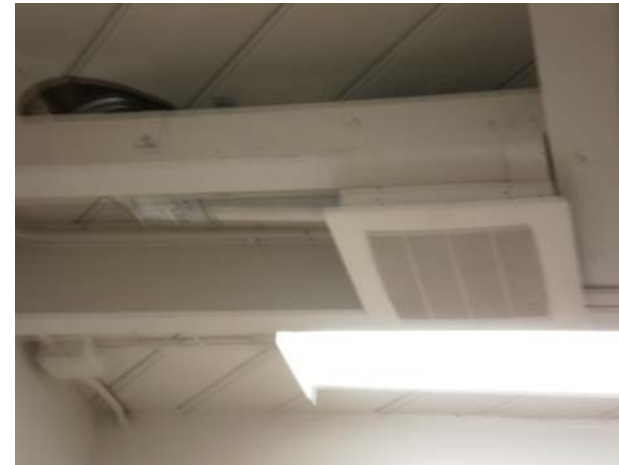
**Energy & Atmosphere**  
*Restrooms are not conditioned. They are only exhausted by dedicated ceiling exhaust fans.*

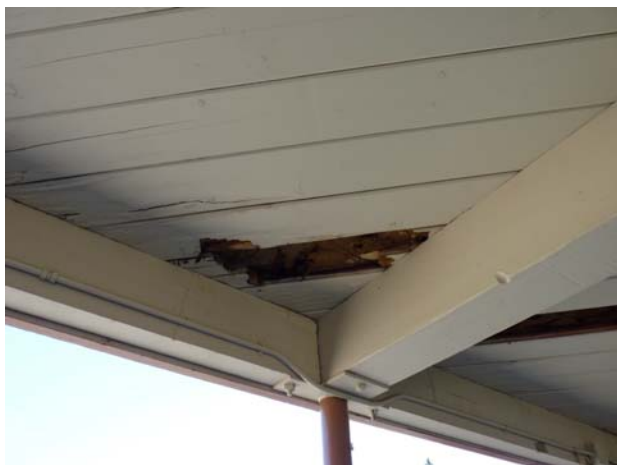
**Materials & Resources Exterior**  
*Water ponding on roof is contributing to the dry rot of the roofing structure.*

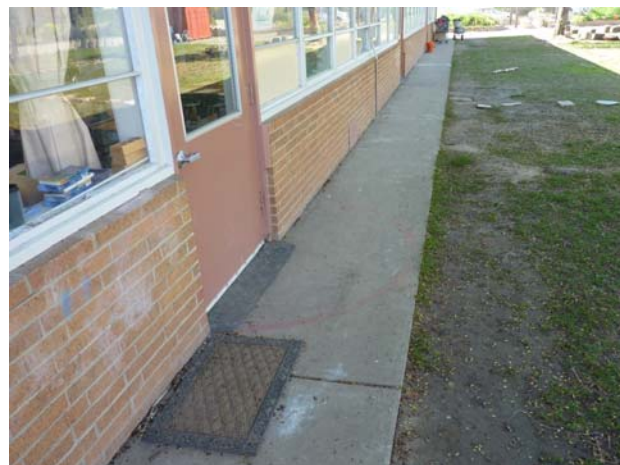
**Materials & Resources Interior**  
*Drainage issues include sidewalk slopes into the building, resulting in doors will not fully close.*

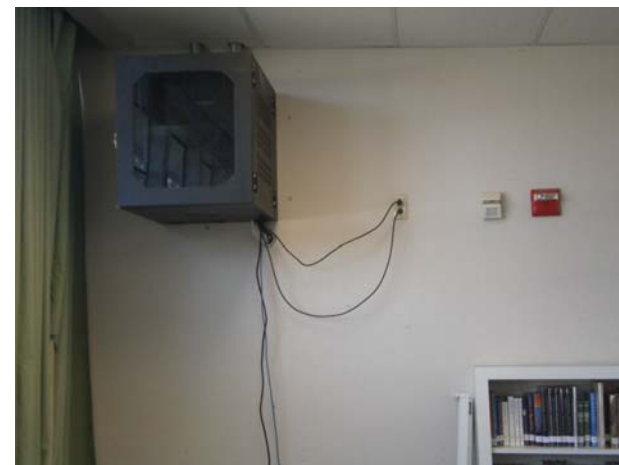
**Indoor Environmental Quality**  
*IDF makes loud motor sounds that disturbs the students and staff.*

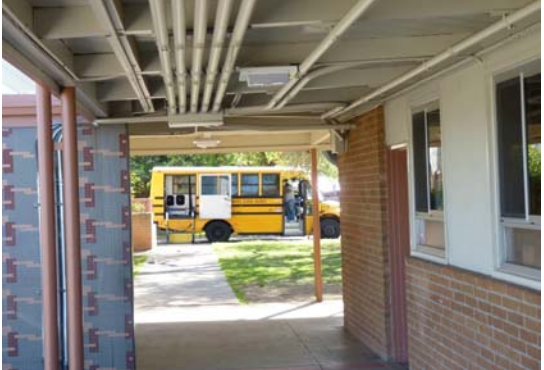
.4	Signage- Identification	03/12	1	C	1	
.5	Signage- Monument	03/12	2	M	2	Access panel is damaged

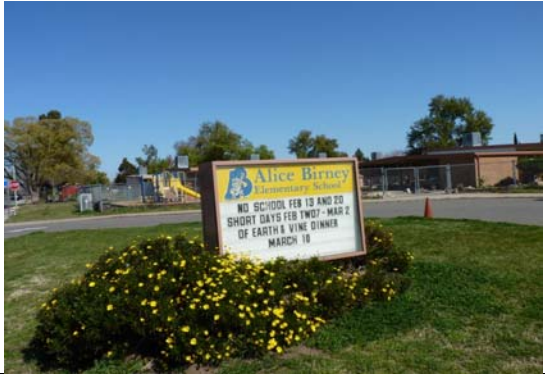
.6	Fence	03/12	4	M	3	Non existing, should be added for security
.7	Gates	03/12	4	M	3	Non existing, should be added for security

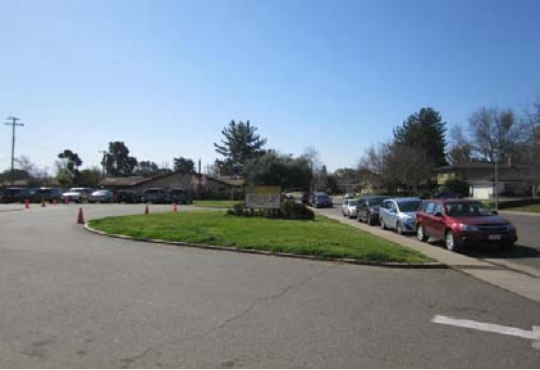
.15	Planting - Trees Adequacy	03/12	4	HP	1	Planting is inadequate. Additional trees should be provided at the drop off, the drive isle and adjacent to the front entry.

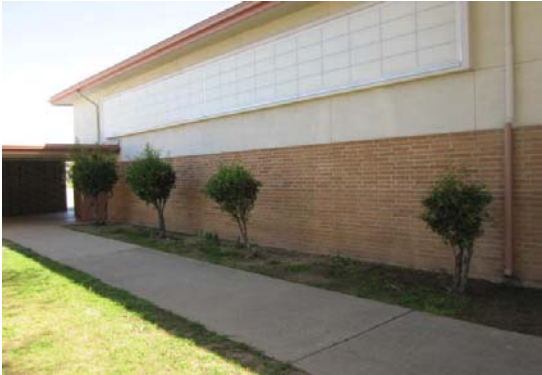
.18	Irrigation Condition	03/12	4	M	2	There exist a mix of systems with old and new heads with the old heads being replaced after failure. All valves are manual.
.19	Irrigation Efficiency	03/12	4	HP	1	Irrigation systems are inefficient. As old heads fail and are replaced with new heads, often the head radius is shorter than the previous head or requires more pressure than previously available. Current system design doesn't meet AB 1881 requirements.

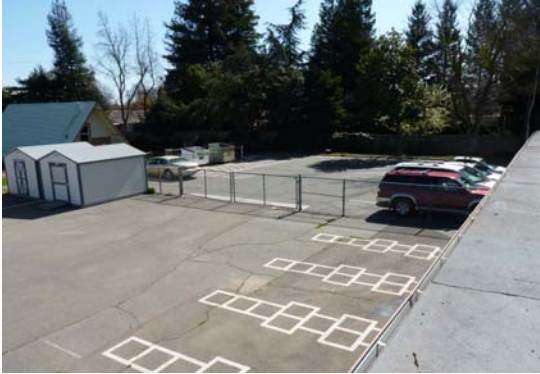
.2	Drive	03/12	2	M	2	Cracked up, needs slurry and re-striping
.3	Staff Parking - Condition	03/12	2	M	2	Cracked up, needs slurry and re-striping
.4	Staff Parking - Adequacy	03/12	4	HP	1	
.5	Student Parking - Condition	03/12	-	-	-	N/A
.6	Student Parking - Adequacy	03/12	-	-	-	N/A
.7	Signage- Identification	03/12	0	C	0	
.8	Fence	03/12	-	-	-	N/A
.9	Gates	03/12	-	-	-	N/A
.10	Site Lighting: Type/Condition	03/12	0	M	0	No site lighting at the Parking and Drive area.

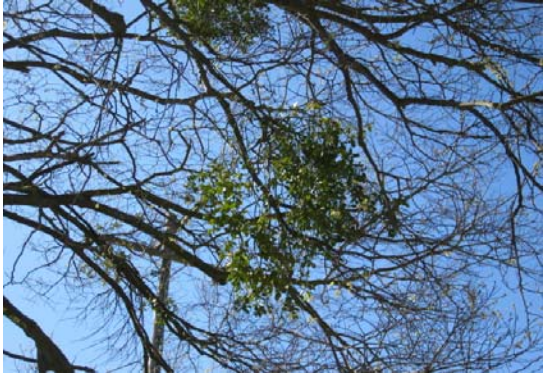
.17	Planting - Trees for Shade Adequacy	03/12	4	HP	1	Shading is inadequate. Only one existing tree is capable of shading the parking lot. The other trees are on the north side of and planted to far away from the curb to provide shade.
.18	Planting-Shrub/Grndcvr Condition	03/12	3	M	1	SHRUB condition is good, however, pruning practices need to be reviewed and corrected. Also die back has left large gaps in the planting bed that should be filled in. TURF coverage is good at about 95%, however, 25% of the turf consist of weeds.

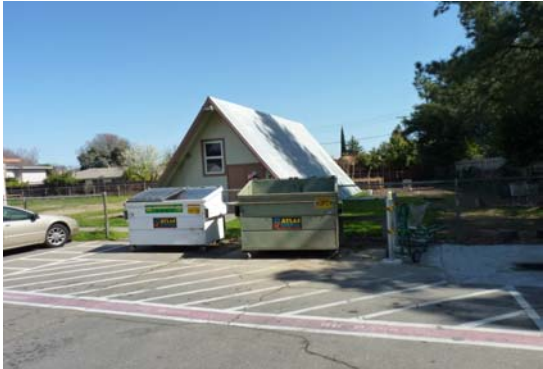
.3	Service Yard	03/12	2	M	2	Cracked up, needs slurry and re-striping
.4	Signage- Identification	03/12	-	-	-	N/A
.5	Fence	03/12	0	M	0	
.6	Gates	03/12	1	M	1	Need adjustment
.7	Site Lighting: Type/Condition	03/12	0	M	0	N/A no site lighting fixture at Service Access area.
.8	Site Lighting: Efficiency/ Cut-off	03/12	2	HP	1	Need pole lighting at Service Access area.
.9	Building Mntd Lighting: Type/Condition	03/12	-	-	-	N/A

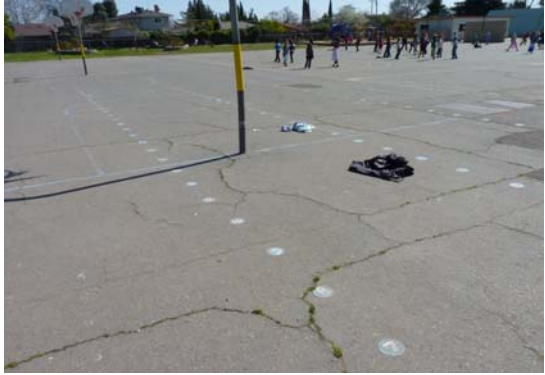
.1 P.O.T./Walks	03/12	-	-	-	N/A
.2 Vehicle Access	03/12	1	M	1	
.3 Paved School Yard / Courts	03/12	3	M	2	Cracked up, needs slurry and re-stripping

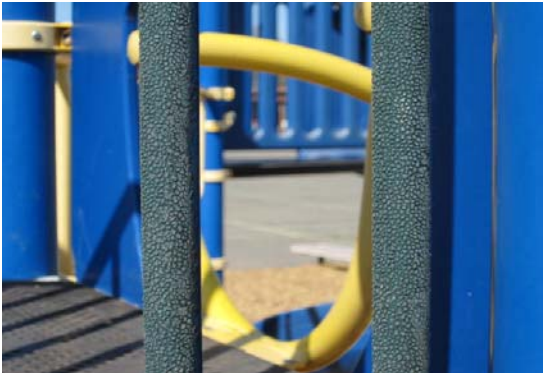
.15 Play Equipment-Kinder	03/12	2	M	2	<p>Play equipment is in fair condition but showing signs of aging. Paint is faded and protective coating on decking is showing signs of degradation. No shade provided.</p>

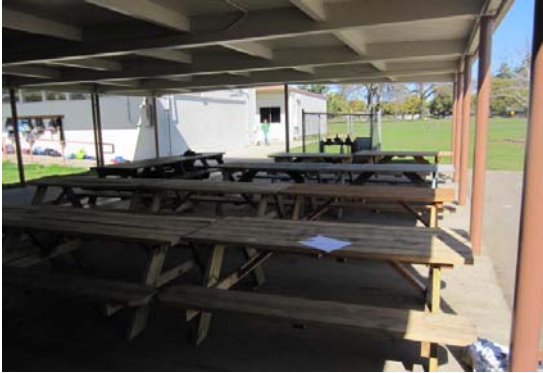
.20 Other Turf Areas	03/12	3	M	1	Same as above.
.21 Outdoor Gathering / Seating Areas	03/12	0	M	0	<p>Outdoor gathering space is located in a covered location at the end of the classroom wings. Multiple wood tables have been provided for the students use. Additional seating has been provided under the overhangs adjacent to the buildings at the hardcourt area.</p> <div style="text-align: center;">

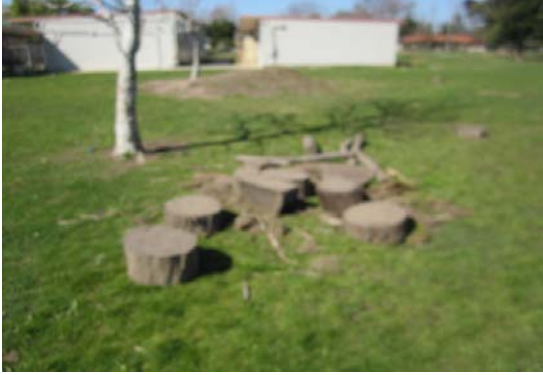
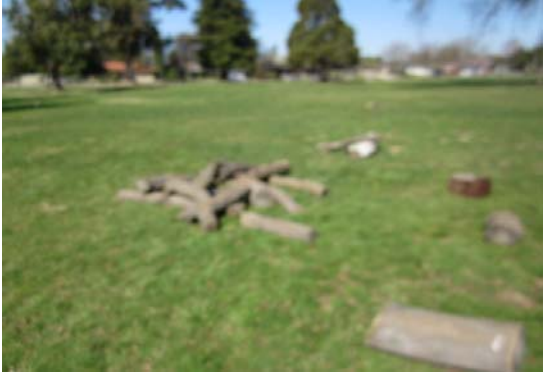
.23 Planting-Trees for Shade Condition	03/12	2	M	1	The trees exist between the hard court and the ball fields appear to be struggling a little bit. The growth is anemic and less than ideal. With time they may improve.

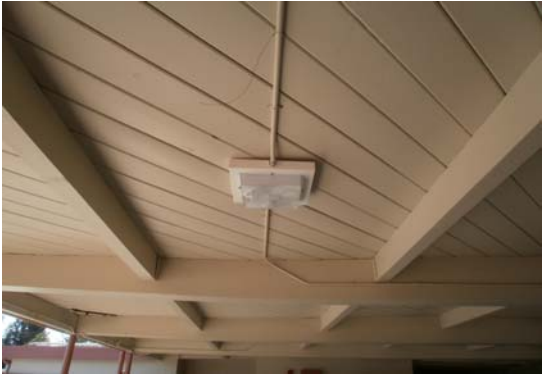
.3	Vehicle Access - Maintenance	03/12	3	M	2	Cracked and need to be slurred
.4	Signage- Identification	03/12	-	-	-	N/A
.5	Fence	03/12	1	M	1	Inconsistent heights, old and rusty
.6	Gates	03/12	1	M	1	
.7	Site Lighting: Type/Condition	03/12	-	-	-	N/A
.8	Site Lighting: Efficiency/ Cut-off	03/12	-	-	-	N/A
.9	Building Mntd Lighting: Type/Condition	03/12	0	M	0	Wall pack and surface canopy lighting in good condition.

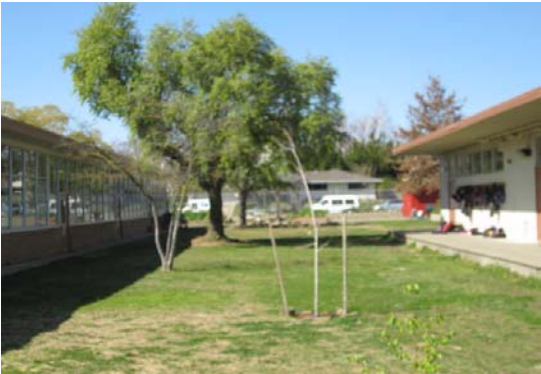
.14	Outdoor Learning Area	03/12	0	M	0	See number 22, Outdoor Leaning Area above.
.15	Trees for Building & Courtyard Shading - Condition	03/12	2	M	1	The tree in the building courtyards are in good to fair condition.
.16	Trees for Building & Courtyard Shading - Adequacy	03/12	4	HP	1	Currently there exist some mature trees and some recent new additions. Shade is inadequate, more trees could still be provided to shade the courtyard and buildings.

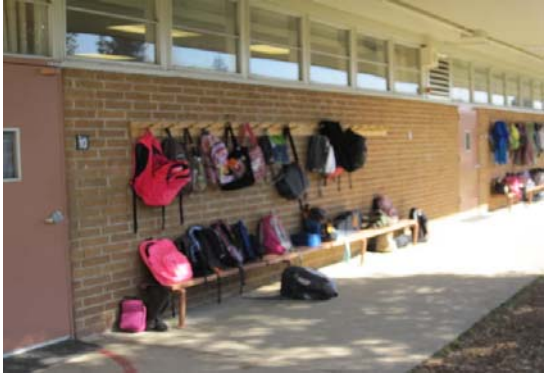
Scope		Date	Repair / Replace Level	Category	Urgency Score	
.22	Site Furnishings	03/12	0	M	0	<p>Original benches attached to building classroom wings. These benches are in good condition.</p>

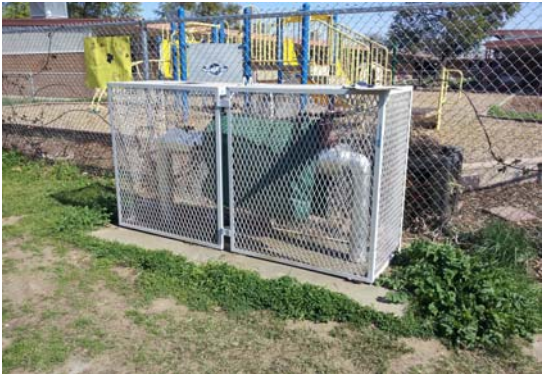
Scope	Date	Repair / Replace Level	Category	Urgency Score	
<p><b>Repair / Replace Level:</b> 4-New Replacement, 3-Major Repair, 2-Minor Repair, 1-Patch &amp; Repair, 0-No observed need to replace, repair or patch  <b>Category:</b> C-Code, M-Maintenance / Operations, HP-High Performance Modernization/Transformation  <b>Urgency Score:</b> 3-Critical, 2-Urgent, not critical, 1-Moderate, recommended, 0-No observed need to replace repair or patch</p>					
<b>Campus Systems</b>					
<b>1. Site Utilities &amp; Infrastructure</b>					
.1 Domestic Water Service: BFP	03/12	0	M	0	Existing 3" metered water service with reduced pressure backflow device found at west perimeter of the site.

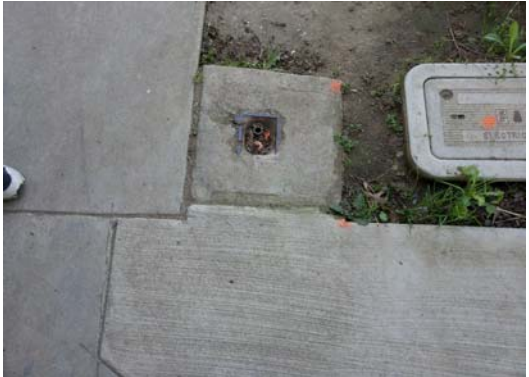
.2 Domestic Water Service: Other	03/12	4	M	3	Existing hose bib at grade. Cover missing, filled with dirt and should not be used without back flow prevention. These should be replaced with new wall mounted hose bibs with vacuum breakers. Suggest 1/2 dozen new hose bibs around campus could be needed.

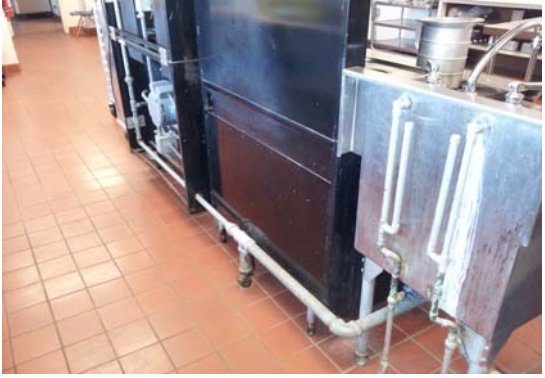
<b>Scope</b>		<b>Date</b>	<b>Repair / Replace Level</b>	<b>Category</b>	<b>Urgency Score</b>	<b>Repair / Replace Level:</b> 4-New Replacement, 3-Major Repair, 2-Minor Repair, 1-Patch & Repair, 0-No observed need to replace, repair or patch <b>Category:</b> C-Code, M-Maintenance / Operations, HP-High Performance Modernization/Transformation <b>Urgency Score:</b> 3-Critical, 2-Urgent, not critical, 1-Moderate, recommended, 0-No observed need to replace repair or patch
.6	Urinals Efficiency	03/12	-	-	-	N/A
.7	Water Closets Condition	03/12	2	C	1	Good Condition. Tank type. Toilet height is lower than 17" height.
.8	Water Closets Efficiency	03/12	0	HP	0	1.6 gallons per flush.
.9	Showers Condition	03/12	-	-	-	N/A
.10	Showers Efficiency	03/12	-	-	-	N/A
.11	Drinking Fountain Cond	03/12	-	-	-	N/A
.12	Drinking Fountain Effic	03/12	-	-	-	N/A
.13	Floor Sinks	03/12	0	M	0	Ok.
.14	Floor Drains	03/12	0	M	0	Ok.
.15	Gas Distribution	03/12	4	C	3	Gas is routed from outdoors underslab to rise through slab at equipment. This needs to be discontinued and new gas should be routed from overhead.

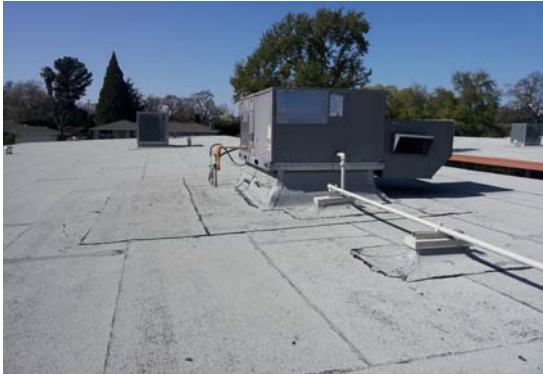
Scope	Date	Repair / Replace Level	Category	Urgency Score	<p><b>Repair / Replace Level:</b> 4-New Replacement, 3-Major Repair, 2-Minor Repair, 1-Patch &amp; Repair, 0-No observed need to replace, repair or patch</p> <p><b>Category:</b> C-Code, M-Maintenance / Operations, HP-High Performance Modernization/Transformation</p> <p><b>Urgency Score:</b> 3-Critical, 2-Urgent, not critical, 1-Moderate, recommended, 0-No observed need to replace repair or patch</p>
<b>Site Utilities &amp; Infrastructure</b>					
<b>1. Central Plant</b>					
.1	Boiler: Condition	03/12	-	-	- NA
.2	Boiler: Efficiency	03/12	-	-	- NA
.3	Chiller: Condition	03/12	-	-	- NA
.4	Chiller: Efficiency	03/12	-	-	- NA
.5	Other	03/12	-	-	- NA
<b>Building - Administration</b>					
<b>1. HVAC Systems</b>					
.1	Equipment: Condition	03/12	2	C	2 Three Existing package gas heat/ electric cooling AC units with on roof. Estimated equipment age unknown, but relatively new and in good condition. One roof top unit has a vent to closed to intake outside air. Recommend relocate vent min 10' away from unit

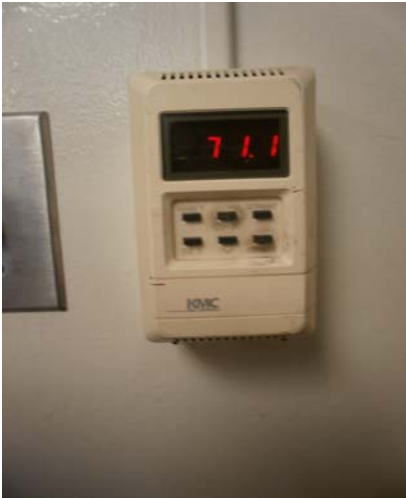
Scope	Date	Repair / Replace Level	Category	Urgency Score	<p><b>Repair / Replace Level:</b> 4-New Replacement, 3-Major Repair, 2-Minor Repair, 1-Patch &amp; Repair, 0-No observed need to replace, repair or patch</p> <p><b>Category:</b> C-Code, M-Maintenance / Operations, HP-High Performance Modernization/Transformation</p> <p><b>Urgency Score:</b> 3-Critical, 2-Urgent, not critical, 1-Moderate, recommended, 0-No observed need to replace repair or patch</p>
.5 EMS Systems: Condition	03/12	2	M	1	<p>KMC control system for all three systems. Recommend to change to District's Standard controls. It seems it is Johnson Controls.</p>

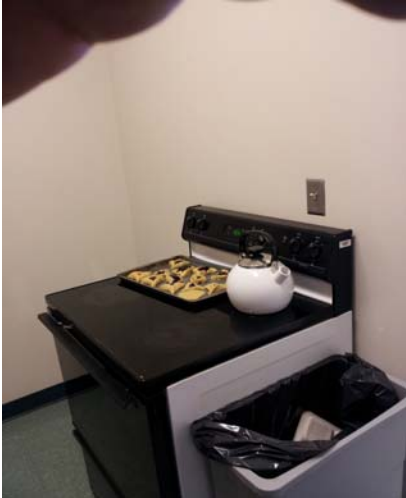
.8 Other		2	M	1	<p>Two residential ranges in Staff Lounge Room need hood with exhaust to outdoor or hood with self contain hood-filter and recirculating air. Recommend to install hood with exhaust fan thru roof or a self contain residential type hood-filter recirculating un</p>

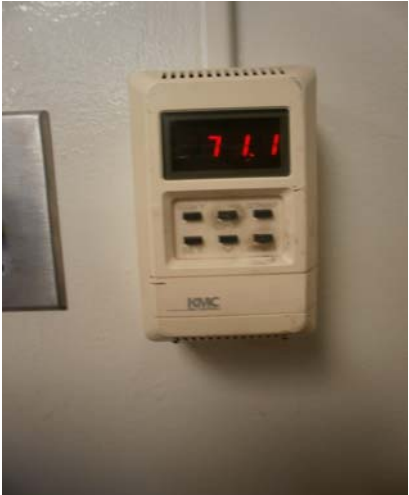
.3	Ductwork	03/12	0	M	0 Roof exposed supply air duct with above ceiling return air duct. Ceiling and wall supply and return air grilles.
.4	Ventilation	03/12	0	M	0 Sufficient for min OSA ventilation. Units have power exhaust and economizer integral to units.
.5	EMS Systems: Condition	03/12	2	M	1 KMC control system for all three systems. Recommend to change to District's Standard controls. It seems it is Johnson Controls.

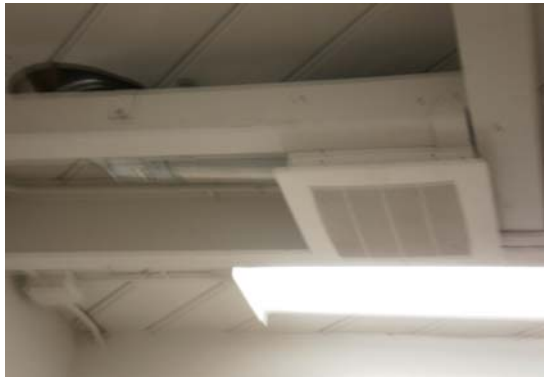
Scope		Date	Repair / Replace Level	Category	Urgency Score	<b>Repair / Replace Level:</b> 4-New Replacement, 3-Major Repair, 2-Minor Repair, 1-Patch & Repair, 0-No observed need to replace, repair or patch <b>Category:</b> C-Code, M-Maintenance / Operations, HP-High Performance Modernization/Transformation <b>Urgency Score:</b> 3-Critical, 2-Urgent, not critical, 1-Moderate, recommended, 0-No observed need to replace repair or patch
.6	EMS Systems: Efficiency	03/12	-	-	-	NA
.7	Other	03/12	-	-	-	NA
<b>2. Specialty Systems</b>						
.1	Dust Collection	03/12	-	-	-	NA
.2	Fume Hoods	03/12	-	-	-	NA
.3	Other	03/12	-	-	-	NA
<b>3. Alternative Energy Systems</b>						
.1	Geo-Thermal	03/12	-	-	-	NA
.2	Solar	03/12	-	-	-	NA
.3	Other	03/12	-	-	-	NA
<b>Building - Student Restrooms</b>						
<b>1. HVAC Systems</b>						
.1	Equipment: Condition	03/12	2	M	1	Restrooms are not conditioned, they are only exhausted by dedicated ceiling exhaust fans.

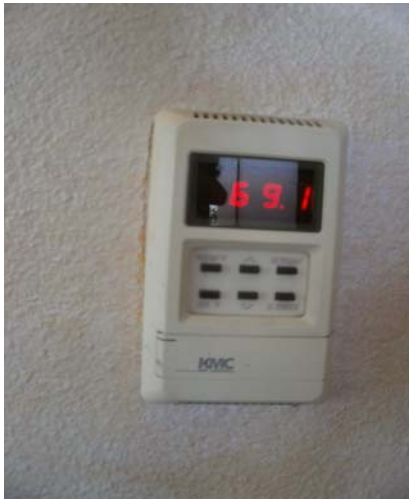
.2	Equipment: Efficiency	03/12	0	HP	0	Existing split systems have Puron (R-410) refrigerant and efficiency relevant to their time of installation. Furnaces are condensing type 90%+ efficient.
.3	Ductwork	03/12	2	M	1	In soffit sidewall SA and RA ducts. Some return air grilles have furniture or other objects too close to grill not permitting return air to have free path back to furnaces. Recommend to keep at least 16 inches of free space in front of the return air grill
.4	Ventilation	03/12	0	M	0	Sufficient for min OSA ventilation could not determine if 100% economizer operations are possible.
.5	EMS Systems: Condition	03/12	2	M	1	KMC controls system in good working condition.

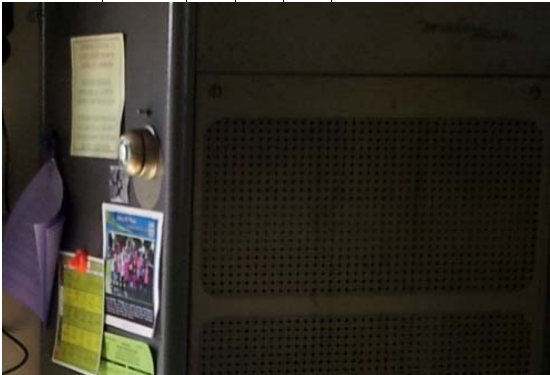
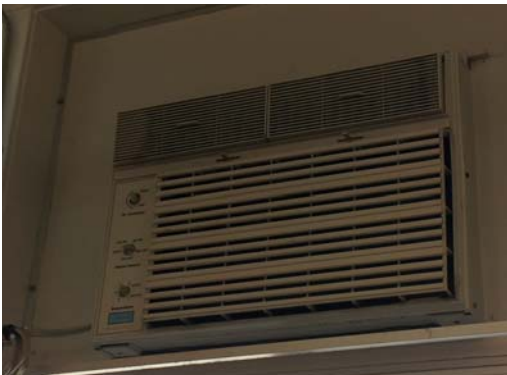
.3	Ductwork	03/12	-	-	-	NA
.4	Ventilation	03/12	0	M	0	No Ventilation air appear to serve the room or system. Open able windows do exist. Adequate size could not be verified.
.5	EMS Systems: Condition	03/12	2	M	1	Old residential type and unit controls.

.6	EMS Systems: Efficiency	03/12	0		0	Recommend to change to District's Standard controls.
.7	Other	03/12	-	-	-	NA
<b>2. Specialty Systems</b>						
.1	Dust Collection	03/12	-	-	-	NA
.2	Fume Hoods	03/12	-	-	-	NA
.3	Other	03/12	-	-	-	NA
<b>3. Alternative Energy Systems</b>						
.1	Geo-Thermal	03/12	-	-	-	NA
.2	Solar	03/12	-	-	-	NA
.3	Other	03/12	-	-	-	NA

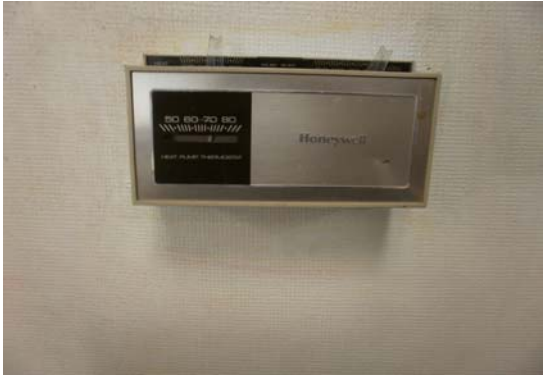
.3	Ductwork	03/12	-	-	-	NA
.4	Ventilation	03/12	0	M	0	Units have minimum OSA opening on them.
.5	EMS Systems: Condition	03/12	2	M	1	Bardd or Honeywell thermostat.

.6	EMS Systems: Efficiency	03/12	2	HP	1	Recommend to change to District's Standard Control system. It seems to be Johnson Controls.
.7	Other	03/12	-	-	-	NA
<b>2. Specialty Systems</b>						
.1	Dust Collection	03/12	-	-	-	NA
.2	Fume Hoods	03/12	-	-	-	NA
.3	Other	03/12	-	-	-	NA
<b>3. Alternative Energy Systems</b>						
.1	Geo-Thermal	03/12	-	-	-	NA
.2	Solar	03/12	-	-	-	NA
.3	Other	03/12	-	-	-	NA

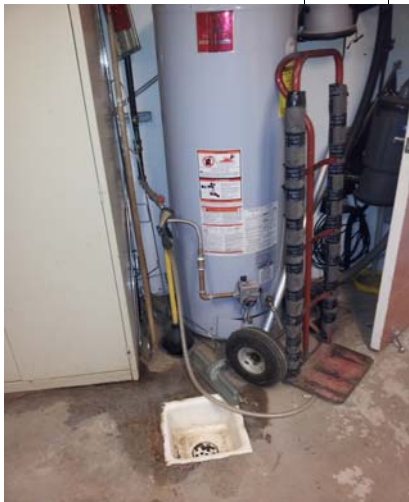
Scope		Date	Repair / Replace Level	Category	Urgency Score	<b>Repair / Replace Level:</b> 4-New Replacement, 3-Major Repair, 2-Minor Repair, 1-Patch & Repair, 0-No observed need to replace, repair or patch <b>Category:</b> C-Code, M-Maintenance / Operations, HP-High Performance Modernization/Transformation <b>Urgency Score:</b> 3-Critical, 2-Urgent, not critical, 1-Moderate, recommended, 0-No observed need to replace repair or patch
<b>Building - Plant Manger</b>						
<b>1. HVAC Systems</b>						
.1	Equipment: Condition	03/12	3	C	2	Room does not have HVAC or exhaust fan. There is water heater that does not have combustion air. Recommend to have install low and high combustion air for water heater and bring HVAC into room with outside air into room if room is to be occupied for long

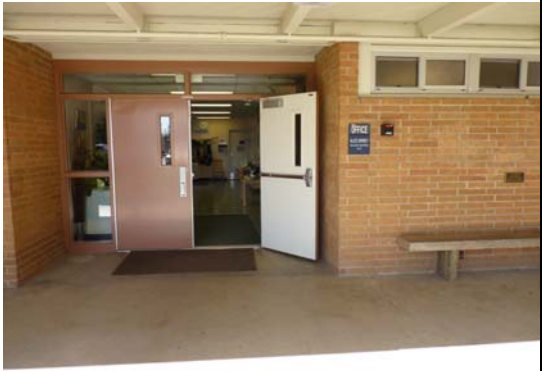
.1	Signage	03/12	4	C	3	Not ADA compliant

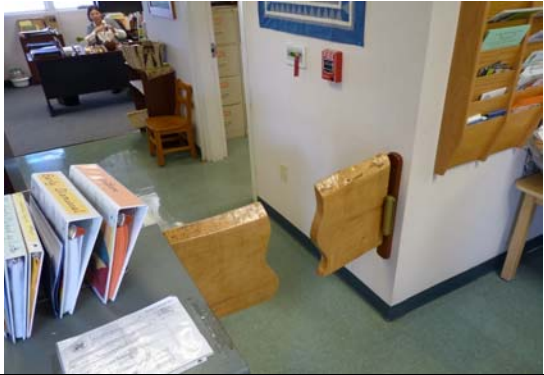
<b>Scope</b>		<b>Date</b>	<b>Repair / Replace Level</b>	<b>Category</b>	<b>Urgency Score</b>	<b>Repair / Replace Level: 4-New Replacement, 3-Major Repair, 2-Minor Repair, 1-Patch &amp; Repair, 0-No observed need to replace, repair or patch Category: C-Code, M-Maintenance / Operations, HP-High Performance Modernization/Transformation Urgency Score: 3-Critical, 2-Urgent, not critical, 1-Moderate, recommended, 0-No observed need to replace repair or patch</b>
.9	Interior Finishes: Casework Condition	03/12	4	M	3	Reception counter not ADA compliant
.10	Interior Finishes: Casework Aesthetic	03/12	4	HP	1	Not ADA compliant casework

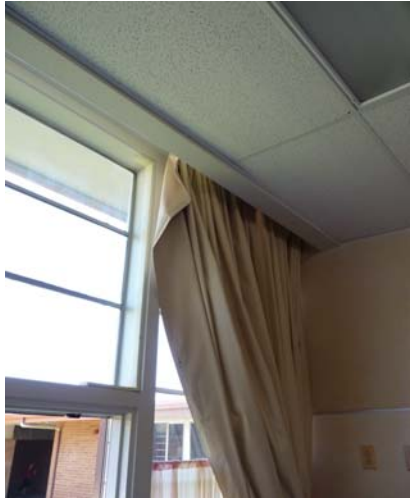
Scope	Date	Repair / Replace Level	Category	Urgency Score	
					<b>Repair / Replace Level:</b> 4-New Replacement, 3-Major Repair, 2-Minor Repair, 1-Patch & Repair, 0-No observed need to replace, repair or patch <b>Category:</b> C-Code, M-Maintenance / Operations, HP-High Performance Modernization/Transformation <b>Urgency Score:</b> 3-Critical, 2-Urgent, not critical, 1-Moderate, recommended, 0-No observed need to replace repair or patch
.12 Interior Finishes Acoustics - Performance	03/12	0	HP	0	
.13 Window Shades: Condition	03/12	1	M	1	
.14 Window Shades: Aesthetic	03/12	4	HP	1	Out-dated and poor color match

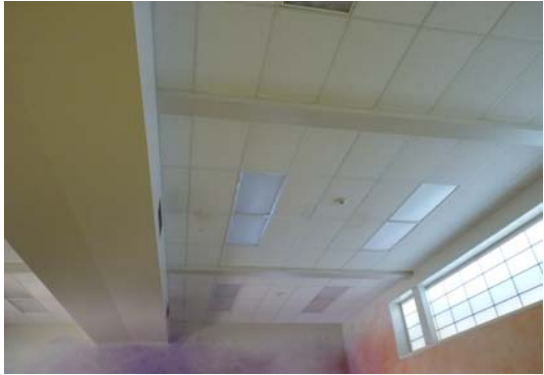
Scope	Date	Repair / Replace Level	Category	Urgency Score	
					<b>Repair / Replace Level:</b> 4-New Replacement, 3-Major Repair, 2-Minor Repair, 1-Patch & Repair, 0-No observed need to replace, repair or patch <b>Category:</b> C-Code, M-Maintenance / Operations, HP-High Performance Modernization/Transformation <b>Urgency Score:</b> 3-Critical, 2-Urgent, not critical, 1-Moderate, recommended, 0-No observed need to replace repair or patch
.7 Interior Finishes: Ceilings Condition	03/12	2	M	2	Replace water stains on ceiling tiles

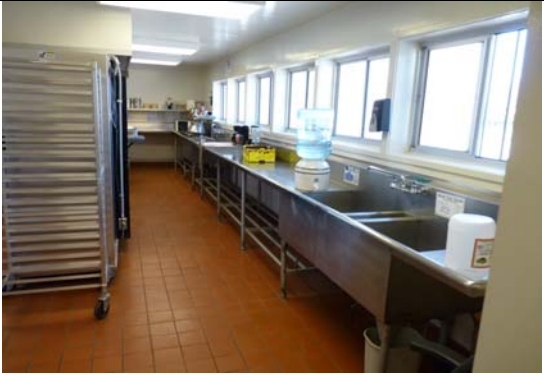
Scope		Date	Repair / Replace Level	Category	Urgency Score		
		<b>Repair / Replace Level:</b> 4-New Replacement, 3-Major Repair, 2-Minor Repair, 1-Patch & Repair, 0-No observed need to replace, repair or patch <b>Category:</b> C-Code, M-Maintenance / Operations, HP-High Performance Modernization/Transformation <b>Urgency Score:</b> 3-Critical, 2-Urgent, not critical, 1-Moderate, recommended, 0-No observed need to replace repair or patch					
.10	Interior Finishes: Casework Aesthetic	03/12	4	HP	1	Update

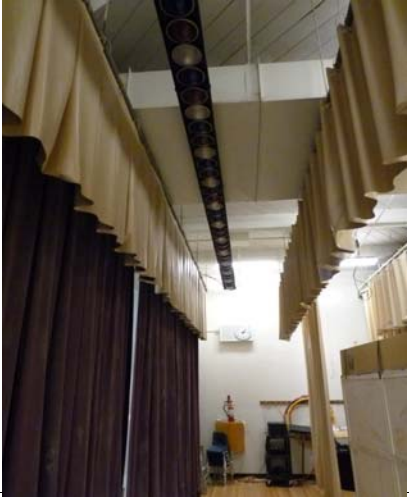
Scope		Date	Repair / Replace Level	Category	Urgency Score	
<b>Repair / Replace Level:</b> 4-New Replacement, 3-Major Repair, 2-Minor Repair, 1-Patch & Repair, 0-No observed need to replace, repair or patch <b>Category:</b> C-Code, M-Maintenance / Operations, HP-High Performance Modernization/Transformation <b>Urgency Score:</b> 3-Critical, 2-Urgent, not critical, 1-Moderate, recommended, 0-No observed need to replace repair or patch						
.13	Stage Curtain: Condition	03/12	1	M	1	
.14	Stage Curtain: Aesthetic	03/12	4	HP	1	Update curtain color and material

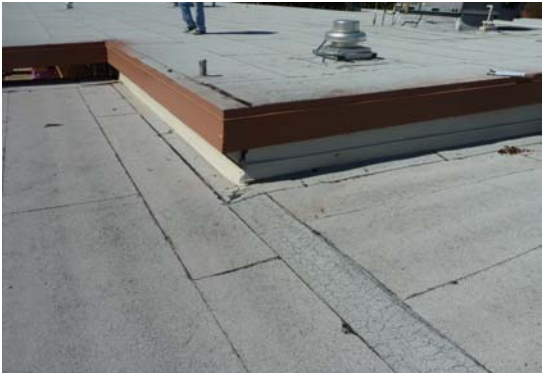
Scope		Date	Repair / Replace Level	Category	Urgency Score	<b>Repair / Replace Level:</b> 4-New Replacement, 3-Major Repair, 2-Minor Repair, 1-Patch & Repair, 0-No observed need to replace, repair or patch <b>Category:</b> C-Code, M-Maintenance / Operations, HP-High Performance Modernization/Transformation <b>Urgency Score:</b> 3-Critical, 2-Urgent, not critical, 1-Moderate, recommended, 0-No observed need to replace repair or patch
.9	Window Systems: Performance	03/12	4	HP	1	
.10	Covered Walks	03/12	1	M	1	
.11	Paint Condition	03/12	1	M	1	
.12	Paint Aesthetic	03/12	0	HP	0	
.13	Other					
<b>2. Building: Classrooms</b>						
.1	Roof: Condition	03/12	2	M	1	Cap sheet shows areas of failure

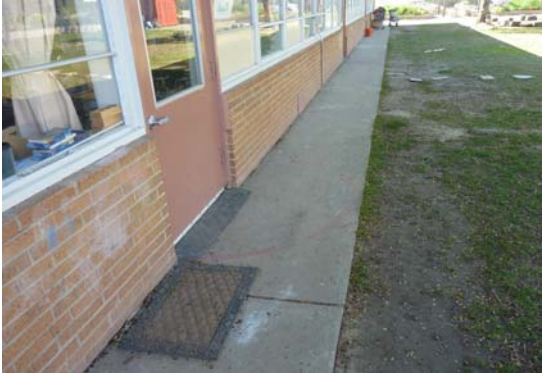
.9	Window Systems: Performance	03/12	4	HP	1	
.10	Covered Walks	03/12	1	M	1	
.11	Paint Condition	03/12	1	M	1	
.12	Paint Aesthetic	03/12	0	HP	0	
.13	Other	03/12	4	M	3	Drainage issues, sidewalk slopes into the building, door will not fully open

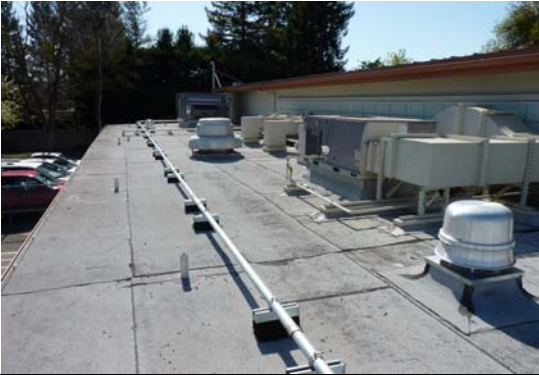
Scope		Date	Repair / Replace Level	Category	Urgency Score	<b>Repair / Replace Level:</b> 4-New Replacement, 3-Major Repair, 2-Minor Repair, 1-Patch & Repair, 0-No observed need to replace, repair or patch <b>Category:</b> C-Code, M-Maintenance / Operations, HP-High Performance Modernization/Transformation <b>Urgency Score:</b> 3-Critical, 2-Urgent, not critical, 1-Moderate, recommended, 0-No observed need to replace repair or patch
<b>3. Building: Multi-Purpose</b>						
.1	Roof: Condition	03/12	3	M	2	Cap sheet failing exposing sub layers of material

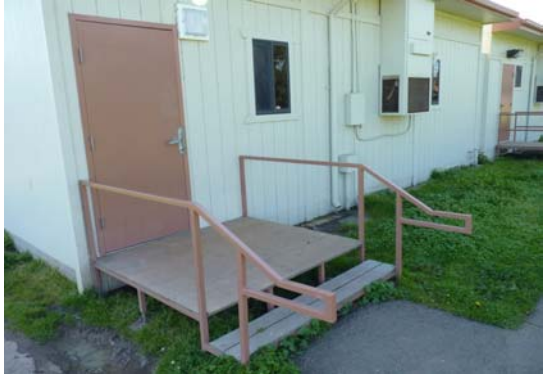
.13	Other	03/12	4	M	3	Drainage issues, water ponding at rear of building

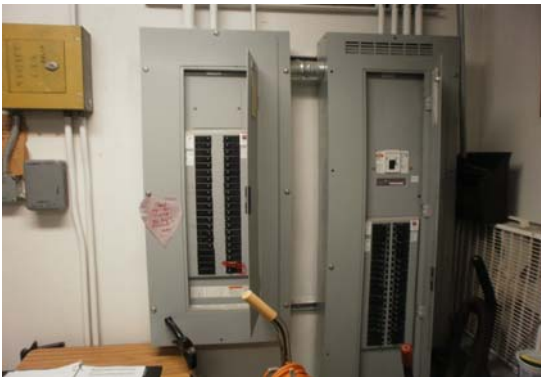
.2	Fire Alarm Control Panel	03/12	0	M	0	Main panel located in boiler/storage room, sufficient.
.3	Access, Intrusion, Security Head End	03/12	0	M	0	Door contacts and motion sensors in most rooms.
<b>Building - Administration</b>						
<b>1. Electrical Systems</b>						
.1	Electrical Rooms, Equipment Location:	03/12	-	-	-	N/A
.2	Panels and Gear:	03/12	0	M	0	New panels installed in 2001, located in Boiler #1.

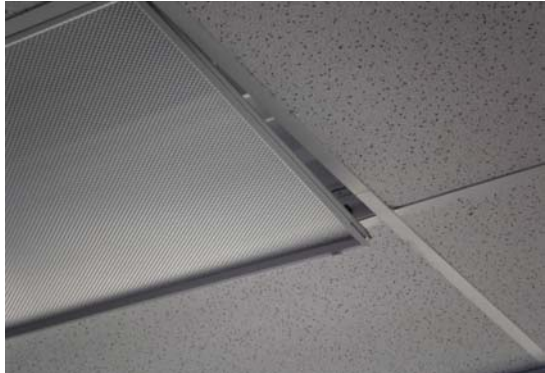
Scope		Date	Repair / Replace Level	Category	Urgency Score	<b>Repair / Replace Level:</b> 4-New Replacement, 3-Major Repair, 2-Minor Repair, 1-Patch & Repair, 0-No observed need to replace, repair or patch <b>Category:</b> C-Code, M-Maintenance / Operations, HP-High Performance Modernization/Transformation <b>Urgency Score:</b> 3-Critical, 2-Urgent, not critical, 1-Moderate, recommended, 0-No observed need to replace repair or patch
<b>2. Lighting Systems</b>						
.1	Light Fixtures: Condition	03/12	2	M	1	2'x4' troffers with 4-lamps and 4' wraparounds with 2-lamps, all in poor condition. Fixtures need to be cleaned and relamped. Some fixtures have lamps with different temperature lamps or lamps out. Latch broken on one fixture.

.2	Light Fixtures: Efficiency	03/12	2	HP	1	Could use new 3-lamp fixtures with energy efficient T8 lamps.
.3	Controls: Condition	03/12	2	M	1	On/off switching with ceiling occupancy sensor.

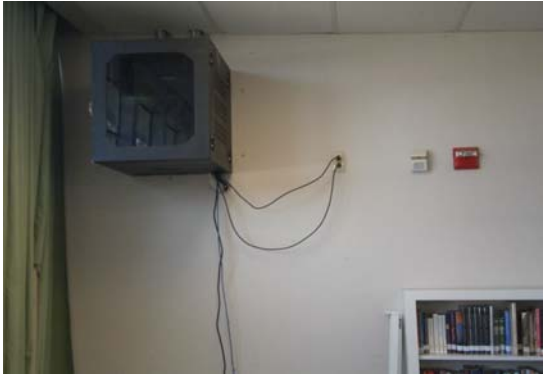
.4	Controls: Efficiency	03/12	0	M	0	
.5	Life Safety / Egress	03/12	2	C	1	No Egress lighting.
.6	Other					
<b>3. Technology Systems</b>						
.1	IDF	03/12	2	M	1	IDF - making loud motor sounds.
