GEORGE WASHINGTON CARVER SCHOOL OF ARTS & SCIENCE

HIGH PERFORMANCE FACILITY ASSESSMENT

NTD
ARCHITECTURE

June 2012

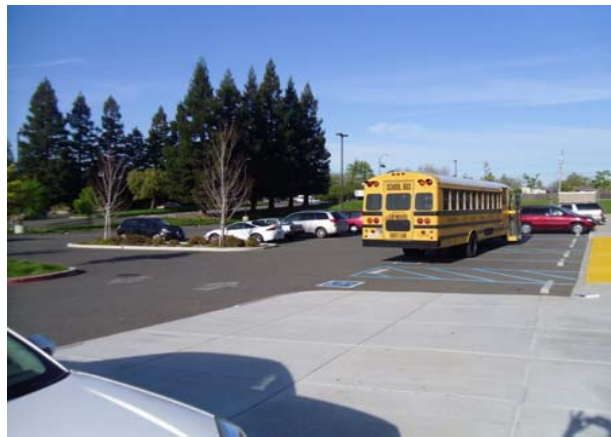
Sustainable Sites - School Entry/Drop Off
There is no designated bus drop off. Improve directional signage and develop an accessible drop-off aisle.

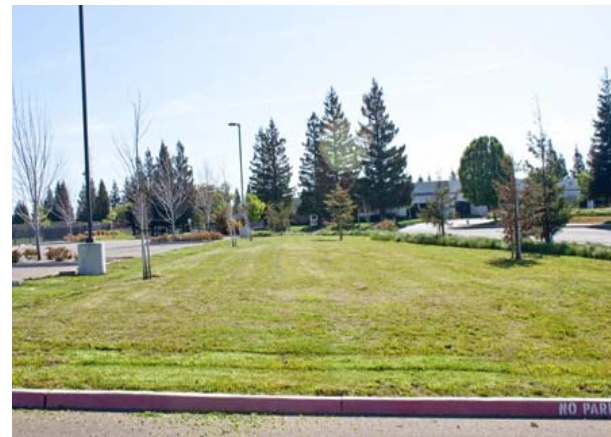
Sustainable Sites - Irrigation
Consider removing excess turf and replanting with low water use plants or no-mow turf.

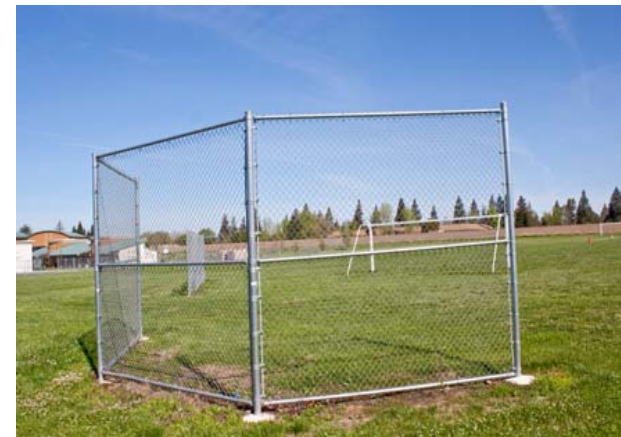
Sustainable Sites - Equip & Furnishings
Sports equipment is in good shape, but is very basic. No spectator seating. Base ball field has no benches. No track for running.

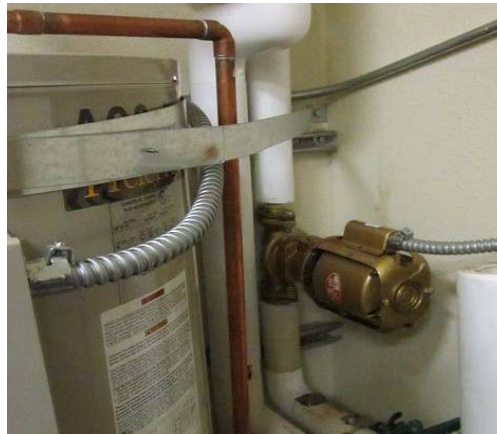
Water Efficiency
No hot water at Science Lab sinks, hot water circulation pump appears to be seized. Recommend repair/replacement of pump.

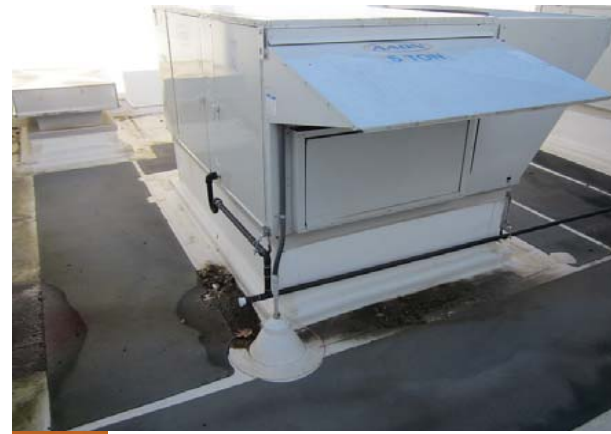
Energy & Atmosphere - Mechanical
Many classrooms exhibit excessive AC unit noise. Further study is recommended.

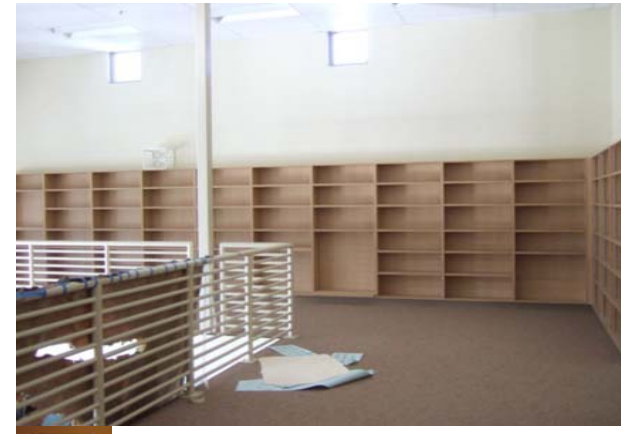
Materials & Resources - Interior
Second floor in library is not in use. Recommend further study to establish efficient use of space.

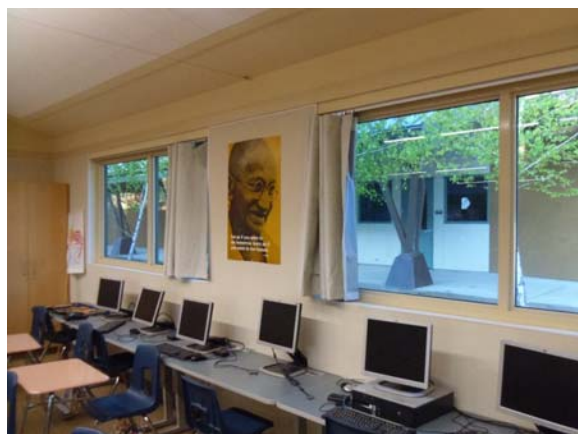
Materials & Resources - Interior
Day lighting and views to the outside. Replace the vinyl curtains with blinds to better control the glare and direct sunlight.

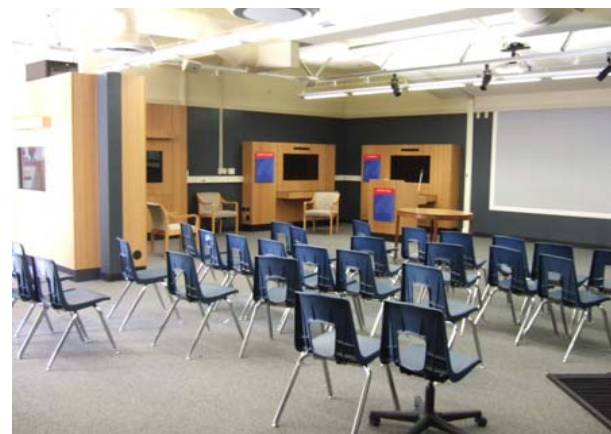
Materials & Resources - Interior
The performing arts program has displaced the digital arts classroom. The classroom has inadequate lighting, no stage and lack of storage.

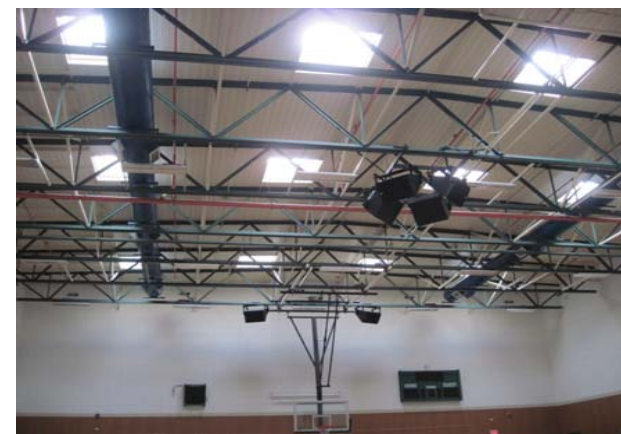
Indoor Environmental Quality
Gym lighting is not multi-level control, which is required by T24. No automatic day lighting control in spaces with ample natural light (gym skylights).

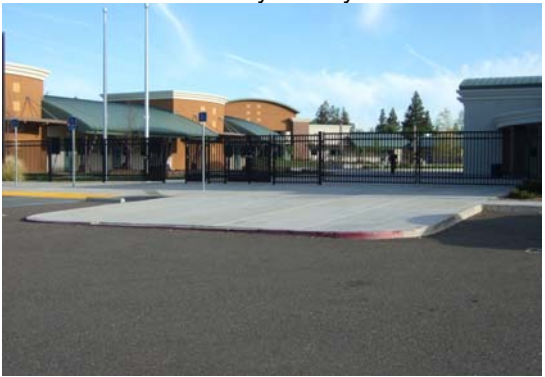
1. School Entry/Drop Off						
.1	P.O.T./Sidewalks	04/12	1	C	3	Non-compliant. See 2009 accessibility survey.
.2	Drive/Drop Off (Parent)	04/12	1	C	3	Non-compliant. See 2009 accessibility survey.

.3	Drive/Drop Off (Bus)	04/12	4	C	3	Non compliant. No bus drop off space.

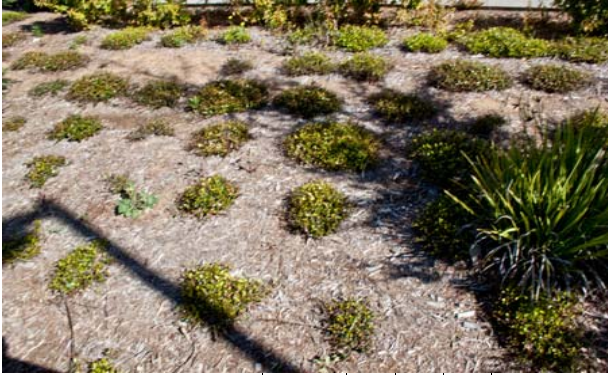
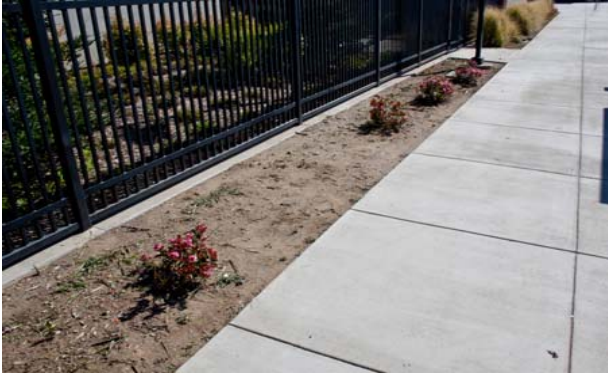
.16 Planting-Shrub/Grndcvr Condition	04/12	2	M	2	Trimmed too tight in many places. Replace any dead or dying plants, remulch.

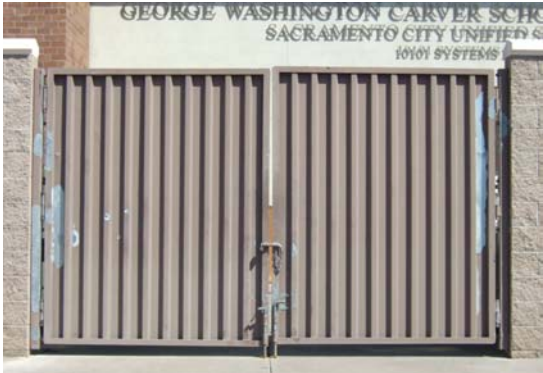
3. Service Access (Fire/Maintenance/Trash Pick Up)						
.1	Drive/Vehicle Access	04/12	0	M	0	
.2	Trash/Recycle Area	04/12	2	M	2	Paint metal gates

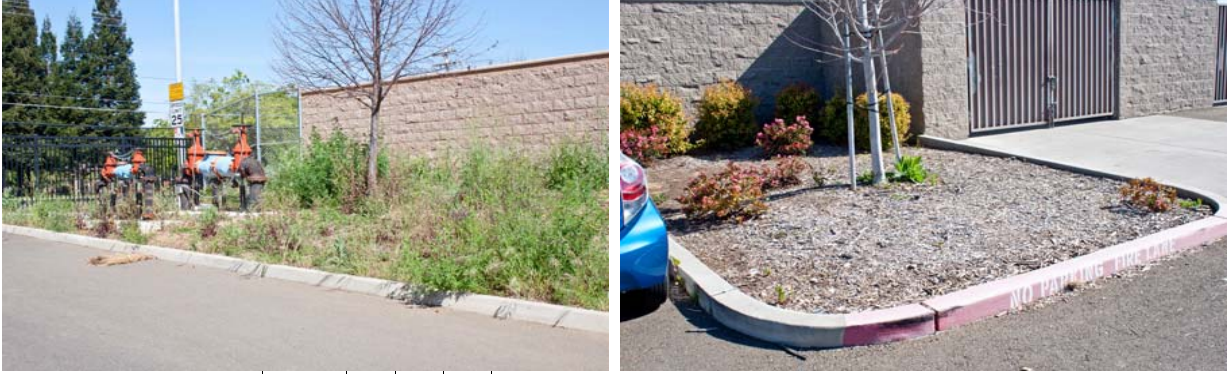
Scope	Date	Repair / Replace Level	Category	Urgency Score	Repair / Replace Level: 4-New Replacement, 3-Major Repair, 2-Minor Repair, 1-Patch & Repair, 0-No observed need to replace, repair or patch Category: C-Code, M-Maintenance / Operations, HP-High Performance Modernization/Transformation Urgency Score: 3-Critical, 2-Urgent, not critical, 1-Moderate, recommended, 0-No observed need to replace repair or patch
.15 Planting-Shrub/Grndcvr Condition	04/12	2	M	2	Shrubs are trimmed too tight in many places. Overgrown weeds at rear service entrance. Replace dead or dying plants, remulch.

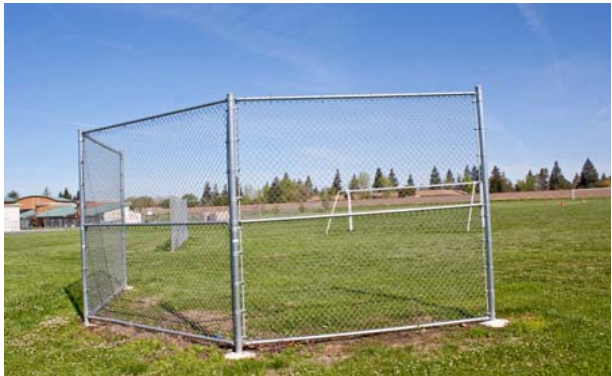
Scope	Date	Repair / Replace Level	Category	Urgency Score	<p>Repair / Replace Level: 4-New Replacement, 3-Major Repair, 2-Minor Repair, 1-Patch & Repair, 0-No observed need to replace, repair or patch</p> <p>Category: C-Code, M-Maintenance / Operations, HP-High Performance Modernization/Transformation</p> <p>Urgency Score: 3-Critical, 2-Urgent, not critical, 1-Moderate, recommended, 0-No observed need to replace repair or patch</p>
.16 Sports / Fitness Equipments	04/12	4	HP	1	<p>Sports equipment is in good shape, but is very basic. No spectator seating. Base ball field has no benches. No track for running.</p>

.17 Tennis Courts	04/12	-	-	-	N/A
.18 Football Field	04/12	-	-	-	N/A
.19 Sports Field	04/12	4	HP	1	<p>See the Athletic Field Assessments and Recommendations Study, dated February 2008 completed by Beals Alliance for additional information.</p>
.20 Other Turf Areas	04/12	0		0	
.21 Outdoor Gathering / Seating Areas	04/12	4	HP	1	<p>Currently none exists. Consider adding seating for gathering opportunities around fields and courts.</p>

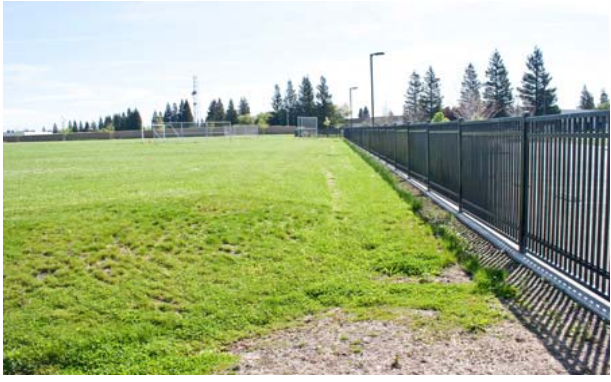
.22 Outdoor Learning Area	04/12	-	-	-	N/A
.23 Planting-Trees for Shade Condition	04/12	0		0	
.24 Planting - Trees for Shade Adequacy	04/12	4	HP	1	<p>Add trees to north & south perimeter of turf fields, and at hardcourt edge.</p>

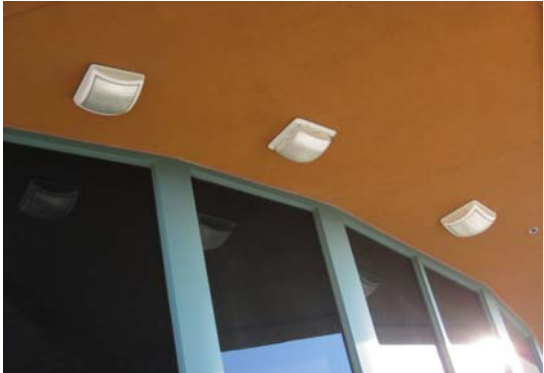
5. Campus Core						
.1	P.O.T./Walks	04/12	1	C	3	Non-compliant. See 2009 accessibility survey.
.2	Vehicle Access - Fire/Emergency	04/12	0	M	0	
.3	Vehicle Access - Maintenance	04/12	0	M	0	
.4	Signage- Identification	04/12	0	M	0	
.5	Fence	04/12	1	M	1	ornamental metal - paint
.6	Gates	04/12	1	M	1	ornamental metal - paint
.7	Site Lighting: Type/Condition	04/12	0	-	0	Adjustable HID floodlights mounted on a pole illuminate outdoor auditorium stage.
.8	Site Lighting: Efficiency/ Cut-off	04/12	0	HP	0	Not cut-off.
.9	Building Mtd Lighting: Type/Condition	04/12	0	-	0	CFL vandal resistant with polycarbonate lens, wall mounted and mounted under canopy. Observed one location at Building H where housing had been removed. Some CFL downlights at Building A

.10	Building Mtd Lighting: Efficiency/ Cut-off	04/12	2	HP	1	Wall mounted fixtures are not cut-off.

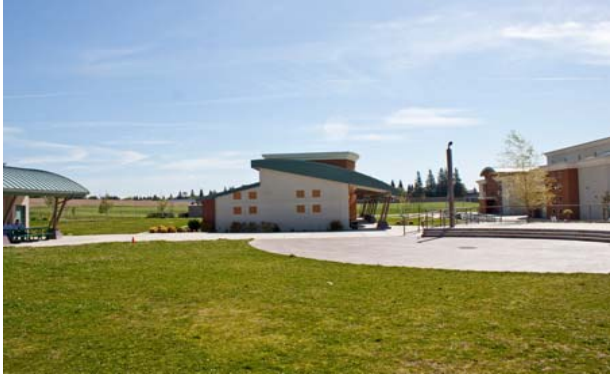
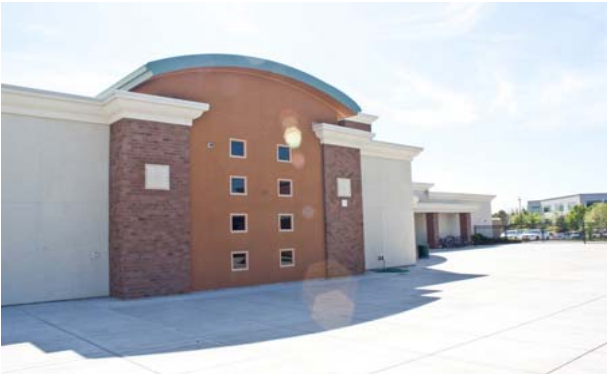
.12 Lighting Controls Efficiency	04/12	0	-	0	Controls are efficient.
.13 Outdoor Gathering Quad	04/12	4	HP	1	<p>Quad provides appropriate gathering place, but not very useful or people friendly when there is no large assembly. In general, Quad feels harsh & is not a place that encourages social interaction. Provide additional seating. Large expanse of high-glare paving needs relief. Provide connection through planting border from table area to turf. Plant trees for shade at perimeter of oval. Turf is bare & weedy. Extensive clover is a bee hazard.</p>

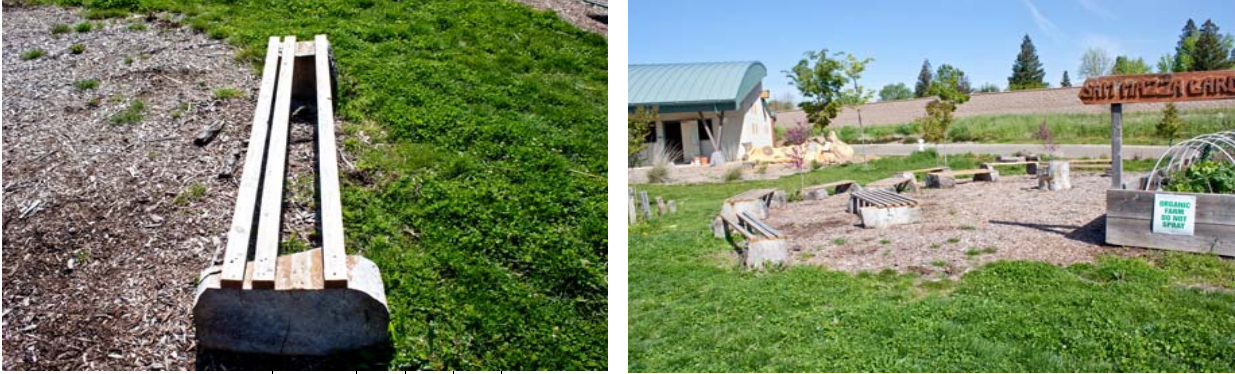
Scope	Date	Repair / Replace Level	Category	Urgency Score	Repair / Replace Level: 4-New Replacement, 3-Major Repair, 2-Minor Repair, 1-Patch & Repair, 0-No observed need to replace, repair or patch Category: C-Code, M-Maintenance / Operations, HP-High Performance Modernization/Transformation Urgency Score: 3-Critical, 2-Urgent, not critical, 1-Moderate, recommended, 0-No observed need to replace repair or patch
.14 Outdoor Learning Area	04/12	3	C	3	Not ADA accessible, Needs ADA entrance, path of travel and seating. Minor repairs to seating needed.

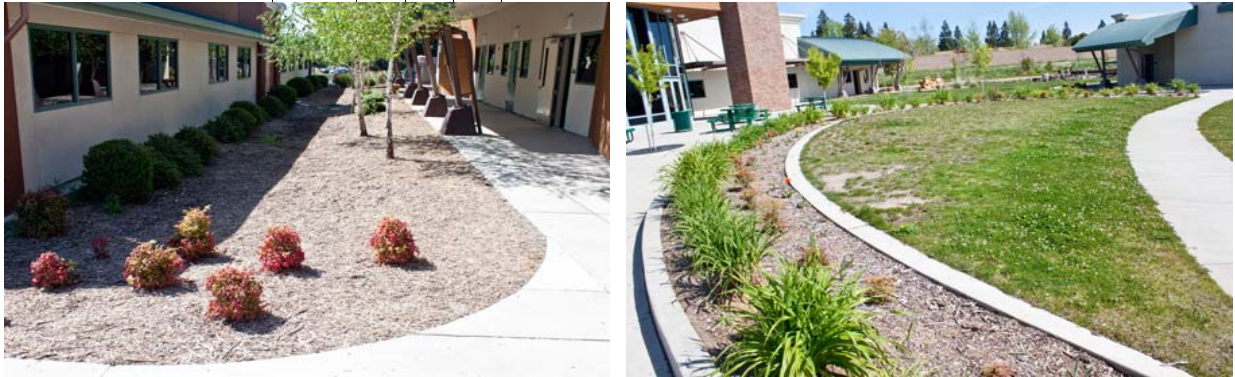
.15 Trees for Building & Courtyard Shading - Condition	04/12	0		0	
.16 Trees for Building & Courtyard Shading - Adequacy	04/12	4	HP	1	Trees are adequate except for center quad. See 5.13.
.17 Planting-Shrub/Grndcvr Condition	04/12	2	M	2	Plants are often trimmed too tight; correct pruning policy to allow natural growth. Replace any dead or dying plants, remulch. Extreme weed problems in all turf on this campus. Entire center lawn is clover. Reseed.

.18 Planting-Shrub/Grndcvr Adequacy	04/12	3	HP	1	Fill in empty planting areas with low water use shrubs and groundcover to achieve dense full coverage.
.19 Irrigation Condition	04/12	0		0	
.20 Irrigation Efficiency	04/12	1	HP	1	Recommend evaluation by an irrigation auditor to assess the site's irrigation system as required by City Model Water Efficient Landscape Ordinance section 15.92.210 & AB 1881.
.21 Storm Water Drainage	04/12	0		0	
.22 Site Furnishings	04/12	3	HP	1	Provide additional seating.
.23 Other

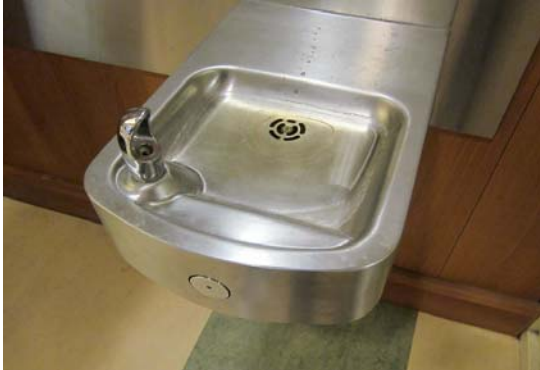
Scope		Date	Repair / Replace Level	Category	Urgency Score	
<p>Repair / Replace Level: 4-New Replacement, 3-Major Repair, 2-Minor Repair, 1-Patch & Repair, 0-No observed need to replace, repair or patch Category: C-Code, M-Maintenance / Operations, HP-High Performance Modernization/Transformation Urgency Score: 3-Critical, 2-Urgent, not critical, 1-Moderate, recommended, 0-No observed need to replace repair or patch</p>						
.11	Drinking Fountain Cond	04/12	2	M	1	Fixtures are in good condition. Drain plugged at one location.

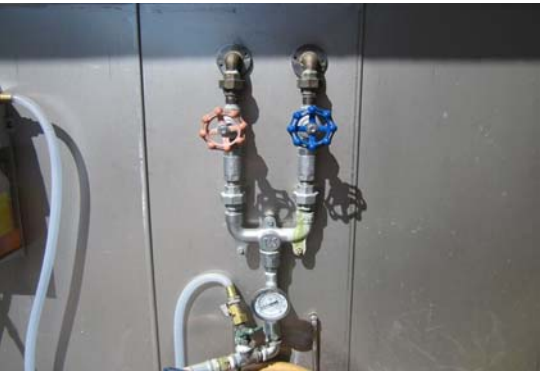
.18	Other	04/12	2	M	1	Can wash exhibits evidence of leakage at threaded pipe joints, recommend repair.

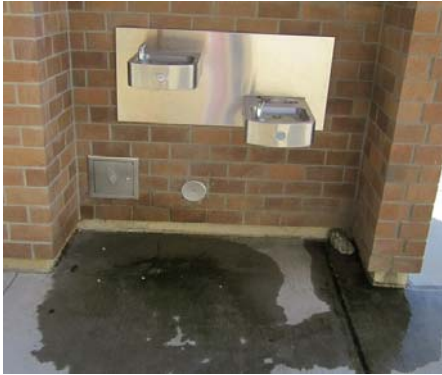
Scope		Date	Repair / Replace Level	Category	Urgency Score	Repair / Replace Level: 4-New Replacement, 3-Major Repair, 2-Minor Repair, 1-Patch & Repair, 0-No observed need to replace, repair or patch Category: C-Code, M-Maintenance / Operations, HP-High Performance Modernization/Transformation Urgency Score: 3-Critical, 2-Urgent, not critical, 1-Moderate, recommended, 0-No observed need to replace repair or patch
.7	Water Closets Condition	04/12	-	-	-	N/A
.8	Water Closets Efficiency	04/12	-	-	-	N/A
.9	Showers Condition	04/12	-	-	-	N/A
.10	Showers Efficiency	04/12	-	-	-	N/A
.11	Drinking Fountain Cond	04/12	2	M	2	Fixtures are in good condition, one valve appears to be leaking. Recommend repair.

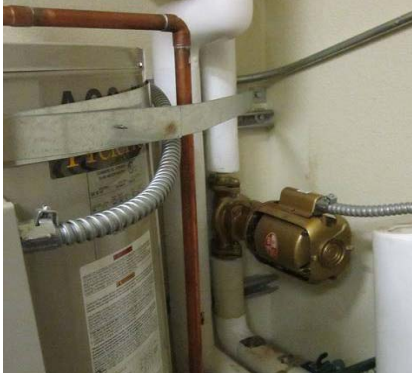
.16	Roof Drain / Overflow	04/12	0	M	0	System is in good condition.
.17	Condensate Drain	04/12	0	M	0	System is in good condition.
.18	Other	04/12	2	M	2	Emergency eye wash and shower systems are in good condition. No hot water at Science Lab sinks, hot water circulation pump appears to be seized. Recommend repair/replacement of pump.

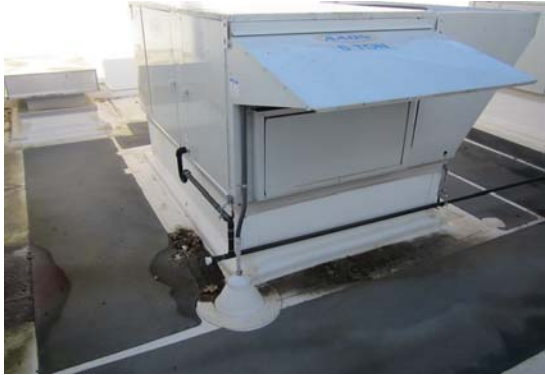
.2	Equipment: Efficiency	04/12	4	HP	2	Recommend installation of VFD on supply fan motor with low fan speed for first stage heating or cooling to reduce classroom noise and reduce energy consumption.
.3	Ductwork	04/12	0	M	0	Ductwork is in good condition.
.4	Ventilation	04/12	0	M	0	Systems provide minimum OA.
.5	EMS Systems: Condition	04/12	0	M	0	The HVAC systems are controlled by a new District wide "Johnson" EMS.
.6	EMS Systems: Efficiency	04/12	-	-	-	N/A
.7	Other

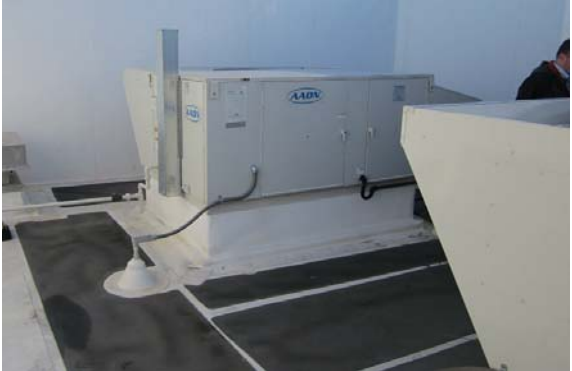
1. HVAC Systems						
.1	Equipment: Condition	04/12	-	M	-	<p>The existing HVAC system consists of roof top package AC units with gas heat. The equipment is 5 years old and is in good condition. Many classrooms exhibit excessive AC unit noise.</p>

.2	Equipment: Efficiency	04/12	4	HP	2	Recommend installation of VFD on supply fan motor with low fan speed for first stage heating or cooling to reduce classroom noise and reduce energy consumption.
.3	Ductwork	04/12	0	M	0	Ductwork is in good condition.
.4	Ventilation	04/12	0	M	0	Systems provide minimum OA.
.5	EMS Systems: Condition	04/12	0	M	0	The HVAC systems are controlled by a new District wide "Johnson" EMS.
.6	EMS Systems: Efficiency	04/12	-	-	-	N/A
.7	Other

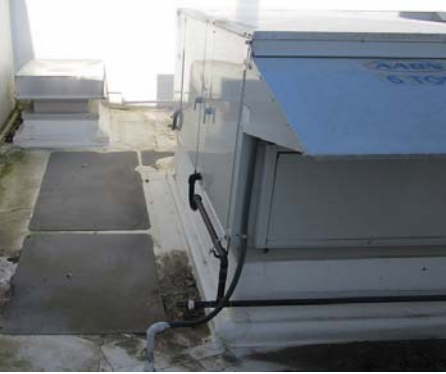
1. HVAC Systems						
.1	Equipment: Condition	04/12	-	M	-	<p>The existing HVAC system consists of roof top package AC units with gas heat. The equipment is 5 years old and is in good condition. Many classrooms exhibit excessive AC unit noise.</p>

.2	Equipment: Efficiency	04/12	4	HP	2	Recommend installation of VFD on supply fan motor with low fan speed for first stage heating or cooling to reduce classroom noise and reduce energy consumption.
.3	Ductwork	04/12	0	M	0	Ductwork is in good condition.
.4	Ventilation	04/12	0	M	0	Systems provide minimum OA.
.5	EMS Systems: Condition	04/12	0	M	0	The HVAC systems are controlled by a new District wide "Johnson" EMS.
.6	EMS Systems: Efficiency	04/12	-	-	-	N/A
.7	Other

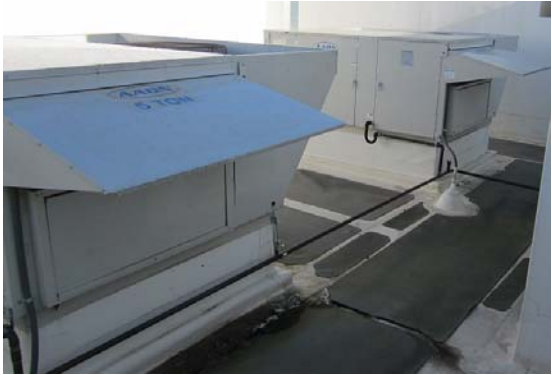
1. HVAC Systems						
.1	Equipment: Condition	04/12	-	M	-	<p>The existing HVAC system consists of roof top package AC units with gas heat. The equipment is 5 years old and is in good condition. Many classrooms exhibit excessive AC unit noise.</p>

.2	Equipment: Efficiency	04/12	4	HP	2	Recommend installation of VFD on supply fan motor with low fan speed for first stage heating or cooling to reduce classroom noise and reduce energy consumption.
.3	Ductwork	04/12	0	M	0	Ductwork is in good condition.
.4	Ventilation	04/12	0	M	0	Systems provide minimum OA.
.5	EMS Systems: Condition	04/12	0	M	0	The HVAC systems are controlled by a new District wide "Johnson" EMS.
.6	EMS Systems: Efficiency	04/12	-	-	-	N/A
.7	Other

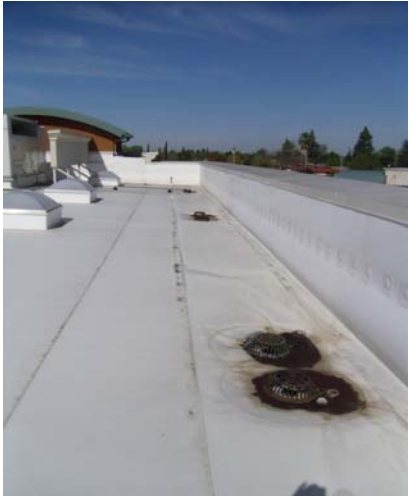
B. EXTERIOR FINISH EVALUATION						
B. EXTERIOR BUILDINGS EVALUATION						
1. Building A: Admin, Multi-Purpose						
.1	Roof: Condition	04/12	1	M	1	Standing seam metal roof & single ply. Single ply roofing is sagging on parapet.

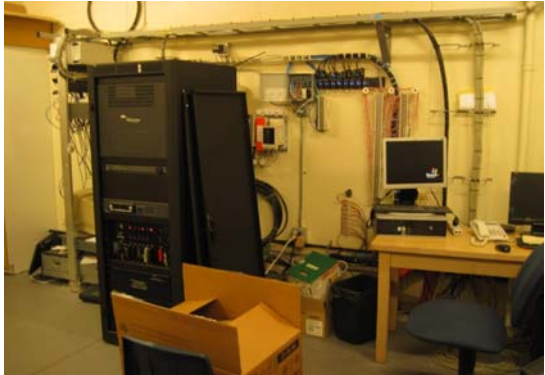
2. Technology Systems						
.1	Utility MPOE/MDF	04/12	1	C	1	MPOE and MDF located in Building A shared electrical room. Adequate size, layout is sufficient, equipment is in new condition. Room is being used for storage, some working clearance requirements not observed.

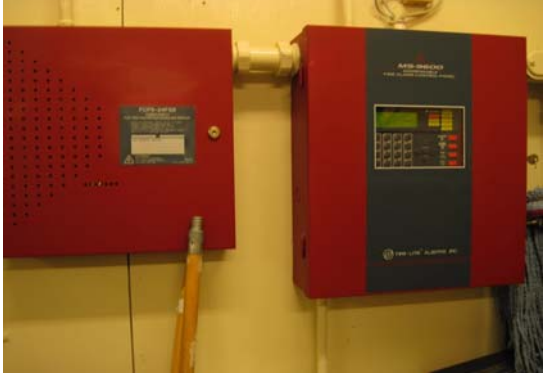
Scope	Date	Repair / Replace Level	Category	Urgency Score	
					Repair / Replace Level: 4-New Replacement, 3-Major Repair, 2-Minor Repair, 1-Patch & Repair, 0-No observed need to replace, repair or patch Category: C-Code, M-Maintenance / Operations, HP-High Performance Modernization/Transformation Urgency Score: 3-Critical, 2-Urgent, not critical, 1-Moderate, recommended, 0-No observed need to replace repair or patch
.2 Fire Alarm Control Panel	04/12	0	-	0	New Fire Lite MS9600 Fully Automatic System

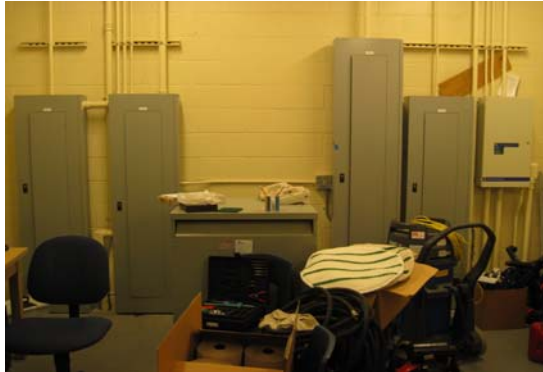
1. Electrical Systems					
.1 Electrical Rooms, Equipment Location:	04/12	1	C	1	Main Electrical room shared with campus MDF, is also being used as storage. Code required working clearance requirements not observed. Panel observed in Janitor's closet.

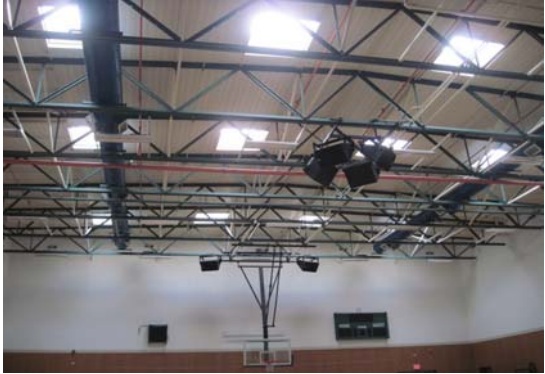
Scope	Date	Repair / Replace Level	Category	Urgency Score	
					Repair / Replace Level: 4-New Replacement, 3-Major Repair, 2-Minor Repair, 1-Patch & Repair, 0-No observed need to replace, repair or patch Category: C-Code, M-Maintenance / Operations, HP-High Performance Modernization/Transformation Urgency Score: 3-Critical, 2-Urgent, not critical, 1-Moderate, recommended, 0-No observed need to replace repair or patch
.2 Light Fixtures: Efficiency	04/12	0	-	0	Fixtures and lamp sources are efficient. Not an instructional space, so CHPS requirements for classroom do not apply.
.3 Controls: Condition	04/12	0	-	0	Line voltage wall switches and ceiling mounted occupancy sensors located in office area, including private offices where a wall sensor would have been more appropriate. Low voltage switches control lighting in gym and lobby via the LCP.
.4 Controls: Efficiency	04/12	1	HP,C	1	Gym lighting is not multi-level control, which is required by T24. No automatic daylighting control in spaces with ample natural light (gym skylights).

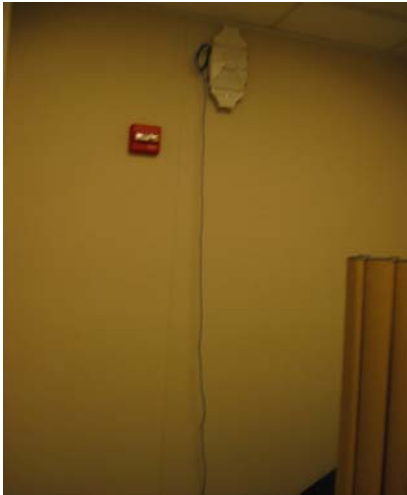
Scope	Date	Repair / Replace Level	Category	Urgency Score	
					<p>Repair / Replace Level: 4-New Replacement, 3-Major Repair, 2-Minor Repair, 1-Patch & Repair, 0-No observed need to replace, repair or patch</p> <p>Category: C-Code, M-Maintenance / Operations, HP-High Performance Modernization/Transformation</p> <p>Urgency Score: 3-Critical, 2-Urgent, not critical, 1-Moderate, recommended, 0-No observed need to replace repair or patch</p>
.3 Workstation / Wireless	04/12	0	-	0	<p>WAPs observed, in some cases data outlet not located properly for the WAP, requiring long patch cord.</p>

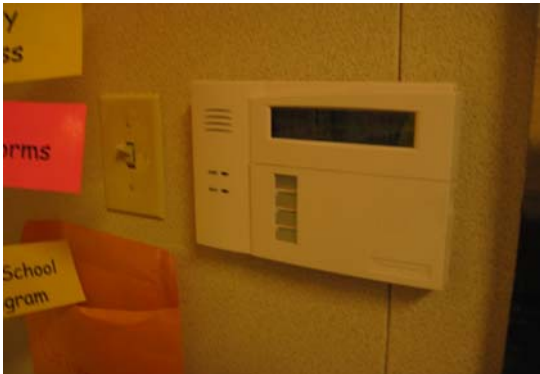
4. Low Voltage Systems					
.1 Clock / PA	04/12	0	-	0	<p>Combination clock/speaker, exterior weatherproof PA speakers observed, in new condition.</p>
.2 Fire Alarm (Devices, Appliances)	04/12	0	-	0	<p>Fully automatic system. Smoke detectors, pull stations, horn/strobes, exterior WP horns observed, in new condition.</p>
.3 Access, Intrusion, Security	04/12	0	-	0	<p>Motion sensors, door contacts observed, in new condition.</p>

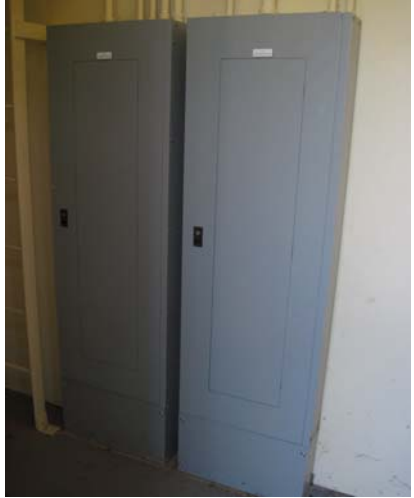
1. Electrical Systems						
.1	Electrical Rooms, Equipment Location:	04/12	0	-	0	Typical utility closet includes 120/208V panel and 277/480V panel, transformer located on roof.

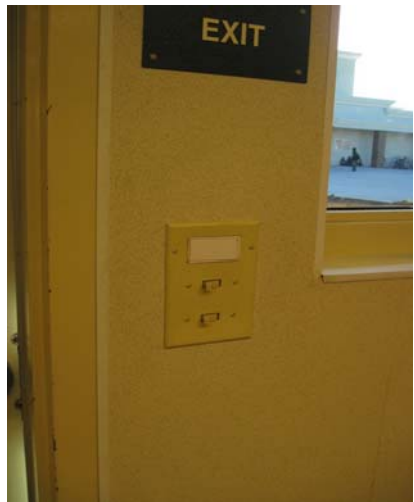
.4	Controls: Efficiency	04/12	2	HP	1	<p>Lighting controls are somewhat efficient. Lighting controls are not CHPS compliant.</p>

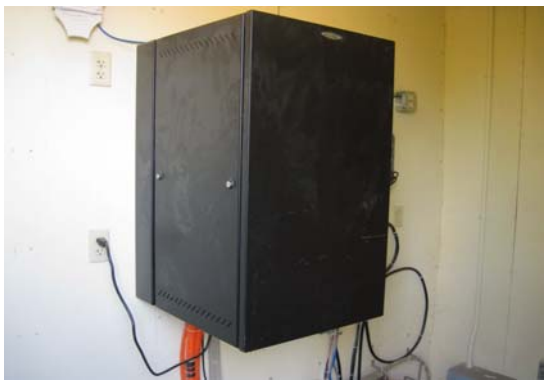
.5	Life Safety / Egress	04/12	0	-	0	Exit lights observed
.6	Other					
3. Technology Systems						
.1	IDF	04/12	0	-	0	<p>IDF cabinet, 'Great Lakes' wall mounted, located in utility closet. Appropriately sized for this building.</p>

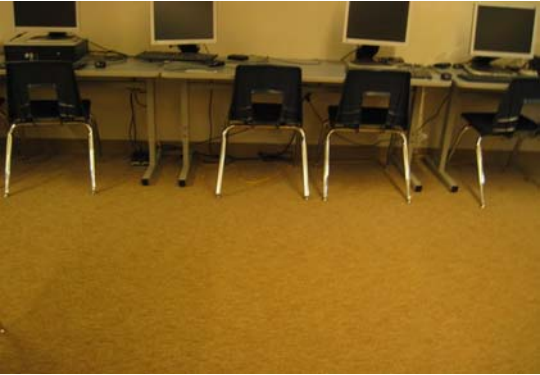
Scope	Date	Repair / Replace Level	Category	Urgency Score		
Repair / Replace Level: 4-New Replacement, 3-Major Repair, 2-Minor Repair, 1-Patch & Repair, 0-No observed need to replace, repair or patch Category: C-Code, M-Maintenance / Operations, HP-High Performance Modernization/Transformation Urgency Score: 3-Critical, 2-Urgent, not critical, 1-Moderate, recommended, 0-No observed need to replace repair or patch						
.3	Workstation / Wireless	04/12	1	M	1	WAPs observed. Limited quantity in classrooms where student workstations have been added.

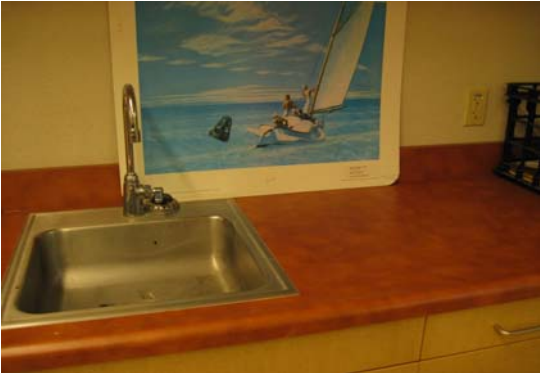
1. Electrical Systems						
.1	Electrical Rooms, Equipment Location:	04/12	0	-	0	Typical utility closet includes 120/208V panel and 277/480V panel, transformer located on roof.
.2	Panels and Gear:	04/12	0	-	0	New condition.
.3	Receptacles / Branch Circuiting	04/12	0	-	0	Observed GFCI receptacles near water source

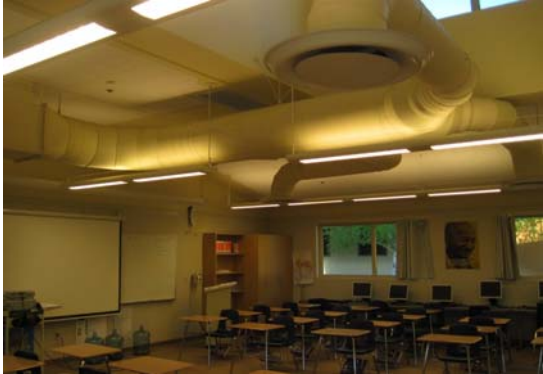
2. Lighting Systems						
.1	Light Fixtures: Condition	04/12	0	-	0	New condition Typical classroom includes pendant mounted indirect/direct fixtures, (2) T8 lamps in cross section, and linear suspended whiteboard light. Adequate seismic bracing observed.
.2	Light Fixtures: Efficiency	04/12	0	-	0	Fixtures and lamp sources are efficient. All fixtures could be re-used in a CHPS compliant classroom.

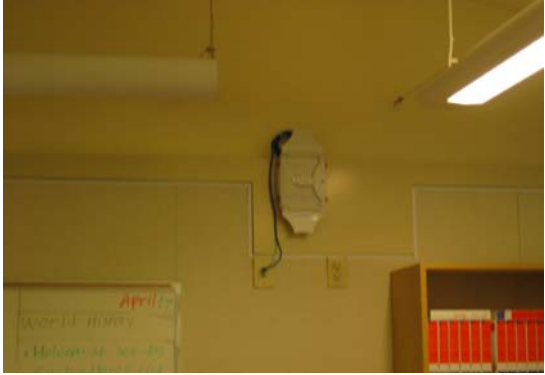
Scope	Date	Repair / Replace Level	Category	Urgency Score		
Repair / Replace Level: 4-New Replacement, 3-Major Repair, 2-Minor Repair, 1-Patch & Repair, 0-No observed need to replace, repair or patch Category: C-Code, M-Maintenance / Operations, HP-High Performance Modernization/Transformation Urgency Score: 3-Critical, 2-Urgent, not critical, 1-Moderate, recommended, 0-No observed need to replace repair or patch						
.3	Workstation / Wireless	04/12	1	M	1	WAPs observed. Limited quantity in classrooms where student workstations have been added.

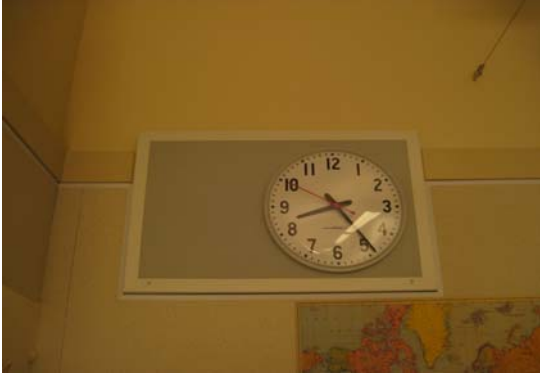
4. Low Voltage Systems					
.1 Clock / PA	04/12	0	-	0	Combination clock/speaker, exterior weatherproof PA speakers observed, in new condition.

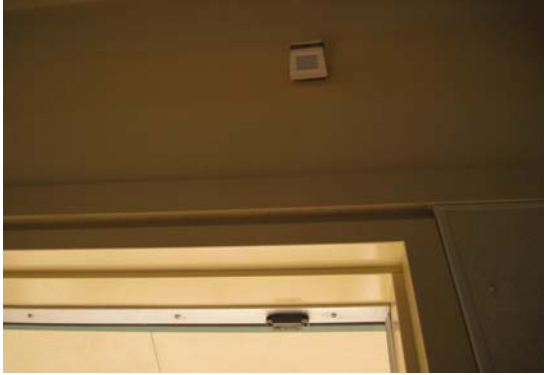
4. Low Voltage Systems						
.1	Clock / PA	04/12	0	-	0	Combination clock/speaker, exterior weatherproof PA speakers observed, in new condition.
.2	Fire Alarm (Devices, Appliances)	04/12	0	-	0	Fully automatic system. Smoke detectors, pull stations, horn/strobes, exterior WP horns observed, in new condition.
.3	Access, Intrusion, Security	04/12	0	-	0	Motion sensors, door contacts observed, in new condition.

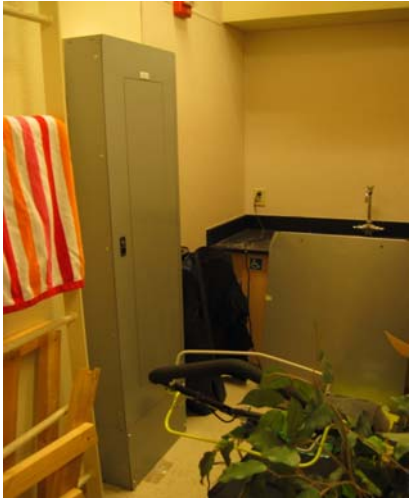
.2 Panels and Gear:	04/12	1	M	1	Doors of panels in utility closet do not close and latch properly.
.3 Receptacles / Branch Circuiting	04/12	0	-	0	<p>Observed GFCI receptacles near water source</p> <p>Observed dual channel surface raceway with GFCI receptacles in labs.</p> <p>Observed receptacles at lab tables</p> <p>Extensive amount of surface raceway used in 'black box' room.</p> <p>Floorbox observed in 'black box'.</p>

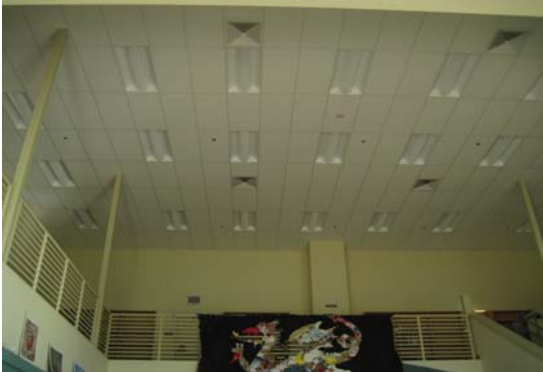
2. Lighting Systems						
.1	Light Fixtures: Condition	04/12	0	-	0	<p>New condition</p> <p>Typical classroom includes pendant mounted indirect/direct fixtures, (2) T8 lamps in cross section, and linear suspended whiteboard light.</p> <p>Adequate seismic bracing observed.</p> <p>2x4 basket fixtures observed in library.</p> <p>Track/display lights observed in 'black box'.</p>

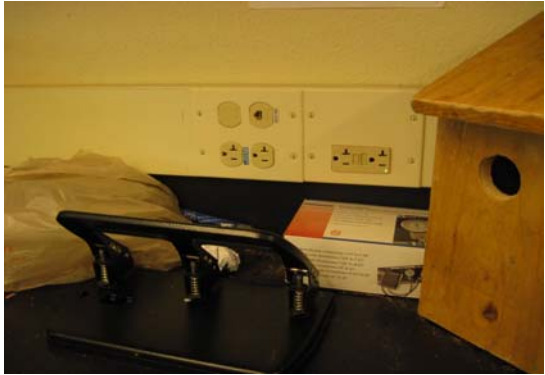
Scope	Date	Repair / Replace Level	Category	Urgency Score	<p>Repair / Replace Level: 4-New Replacement, 3-Major Repair, 2-Minor Repair, 1-Patch & Repair, 0-No observed need to replace, repair or patch</p> <p>Category: C-Code, M-Maintenance / Operations, HP-High Performance Modernization/Transformation</p> <p>Urgency Score: 3-Critical, 2-Urgent, not critical, 1-Moderate, recommended, 0-No observed need to replace repair or patch</p>
.2 Infrastructure (Raceway, Cabling)	04/12	0	-	0

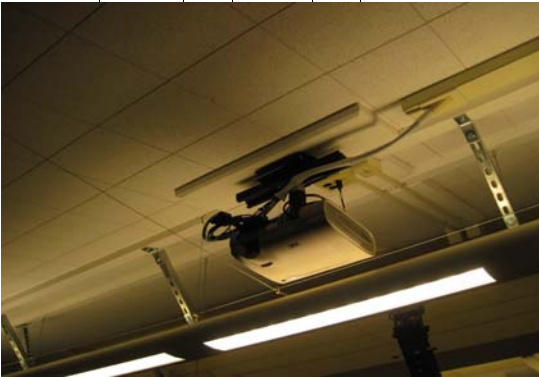
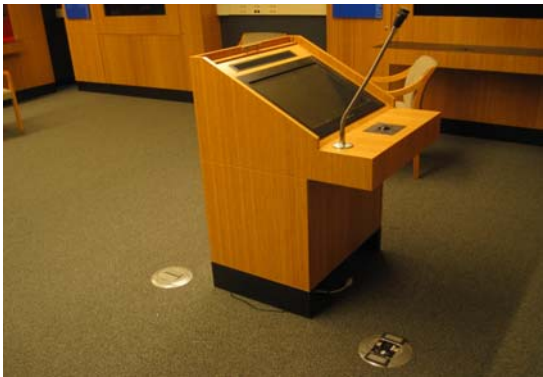
.3 Workstation / Wireless	04/12	1	M	1	<p>WAPs observed.</p> <p>Observed dual channel surface raceway at labs</p> <p>Floorbox with data observed at 'black box'</p>
.4 AV Systems	04/12	2	M	1	<p>Manual projection screen in labs, mobile AV cart shared between rooms.</p> <p>Projector, audio system, AV controls and mobile lectern observed in 'black box'</p>

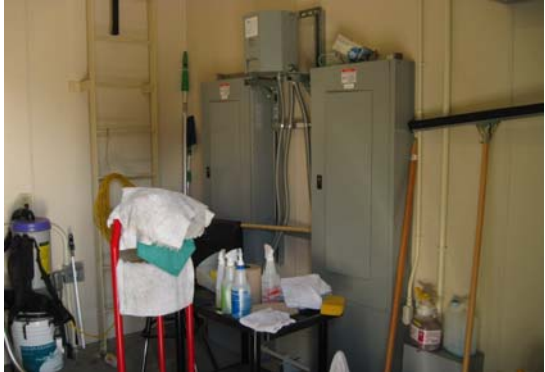
1. Electrical Systems						
.1	Electrical Rooms, Equipment Location:	04/12	0	-	0	Located in Janitor's closet, working clearance requirements not observed by users.

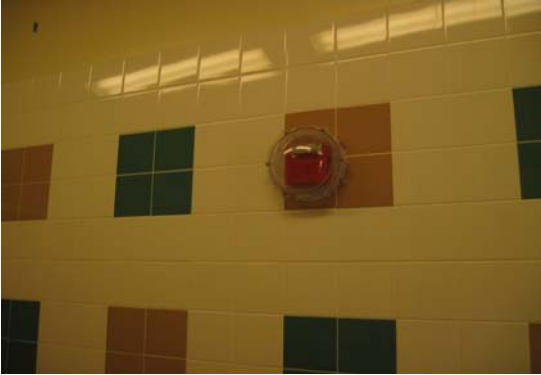
Scope	Date	Repair / Replace Level	Category	Urgency Score	<p>Repair / Replace Level: 4-New Replacement, 3-Major Repair, 2-Minor Repair, 1-Patch & Repair, 0-No observed need to replace, repair or patch</p> <p>Category: C-Code, M-Maintenance / Operations, HP-High Performance Modernization/Transformation</p> <p>Urgency Score: 3-Critical, 2-Urgent, not critical, 1-Moderate, recommended, 0-No observed need to replace repair or patch</p>
4. Low Voltage Systems					
.1	Clock / PA	04/12	0	-	0 Exterior weatherproof PA speakers observed, in new condition.
.2	Fire Alarm (Devices, Appliances)	04/12	0	-	0 Fully automatic system. Smoke detectors, pull stations, horn/strobes, exterior WP horns observed, in new condition.
