**Skills and Business Center**  
Portable Building Inventory Summary Sheet

# Florin Technology Education Center (Adult Ed)

# Fremont School for Adults

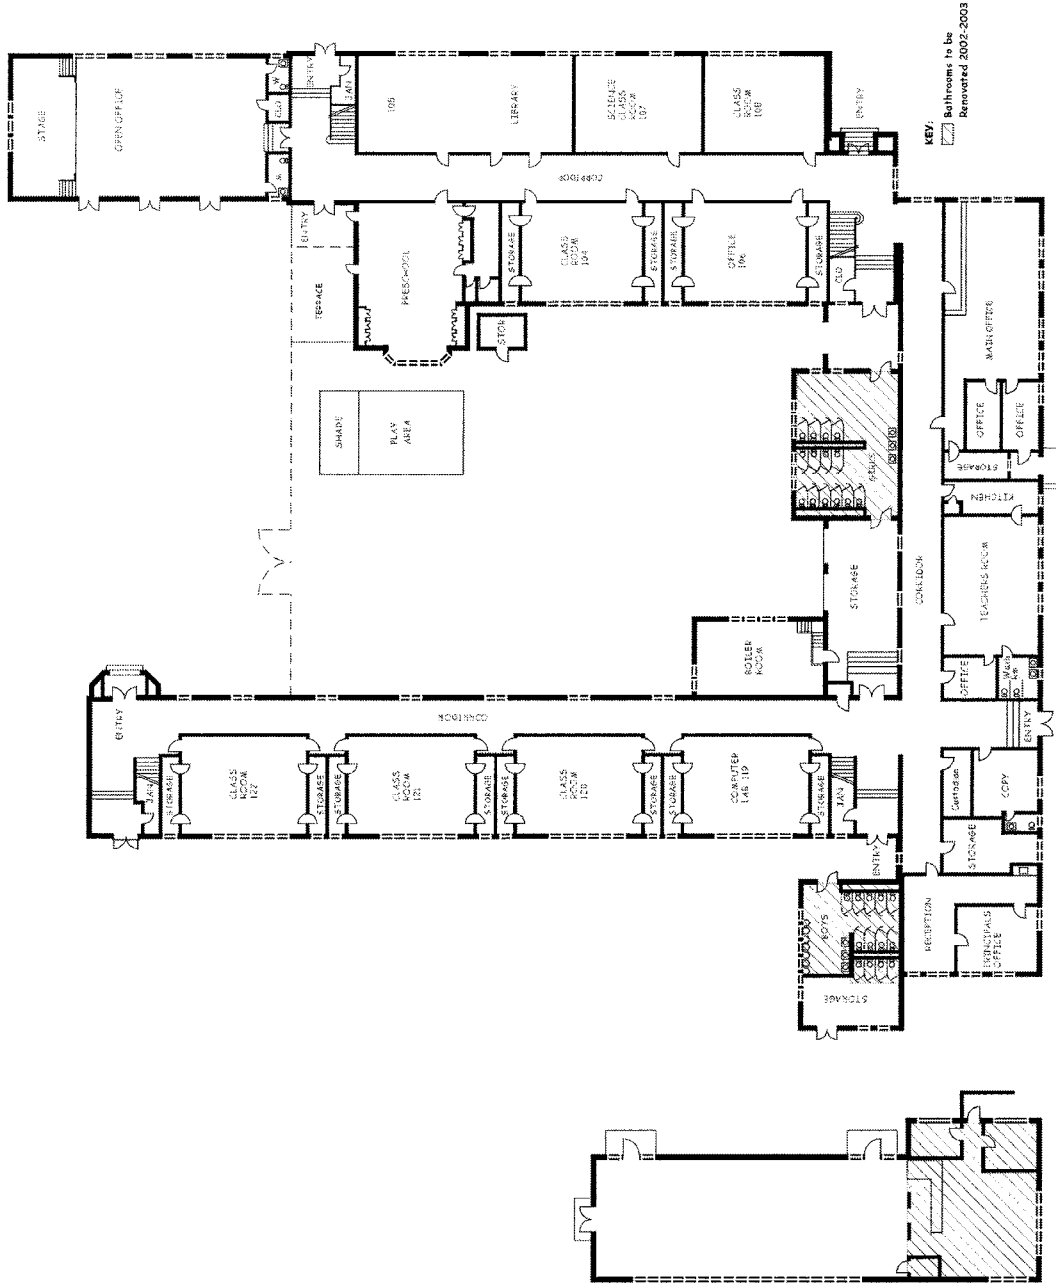
**FIRST FLOOR PLAN**  
27,657 GSF

**SACRAMENTO CITY  
UNIFIED SCHOOL DISTRICT  
FREMONT SCHOOL FOR ADULTS**

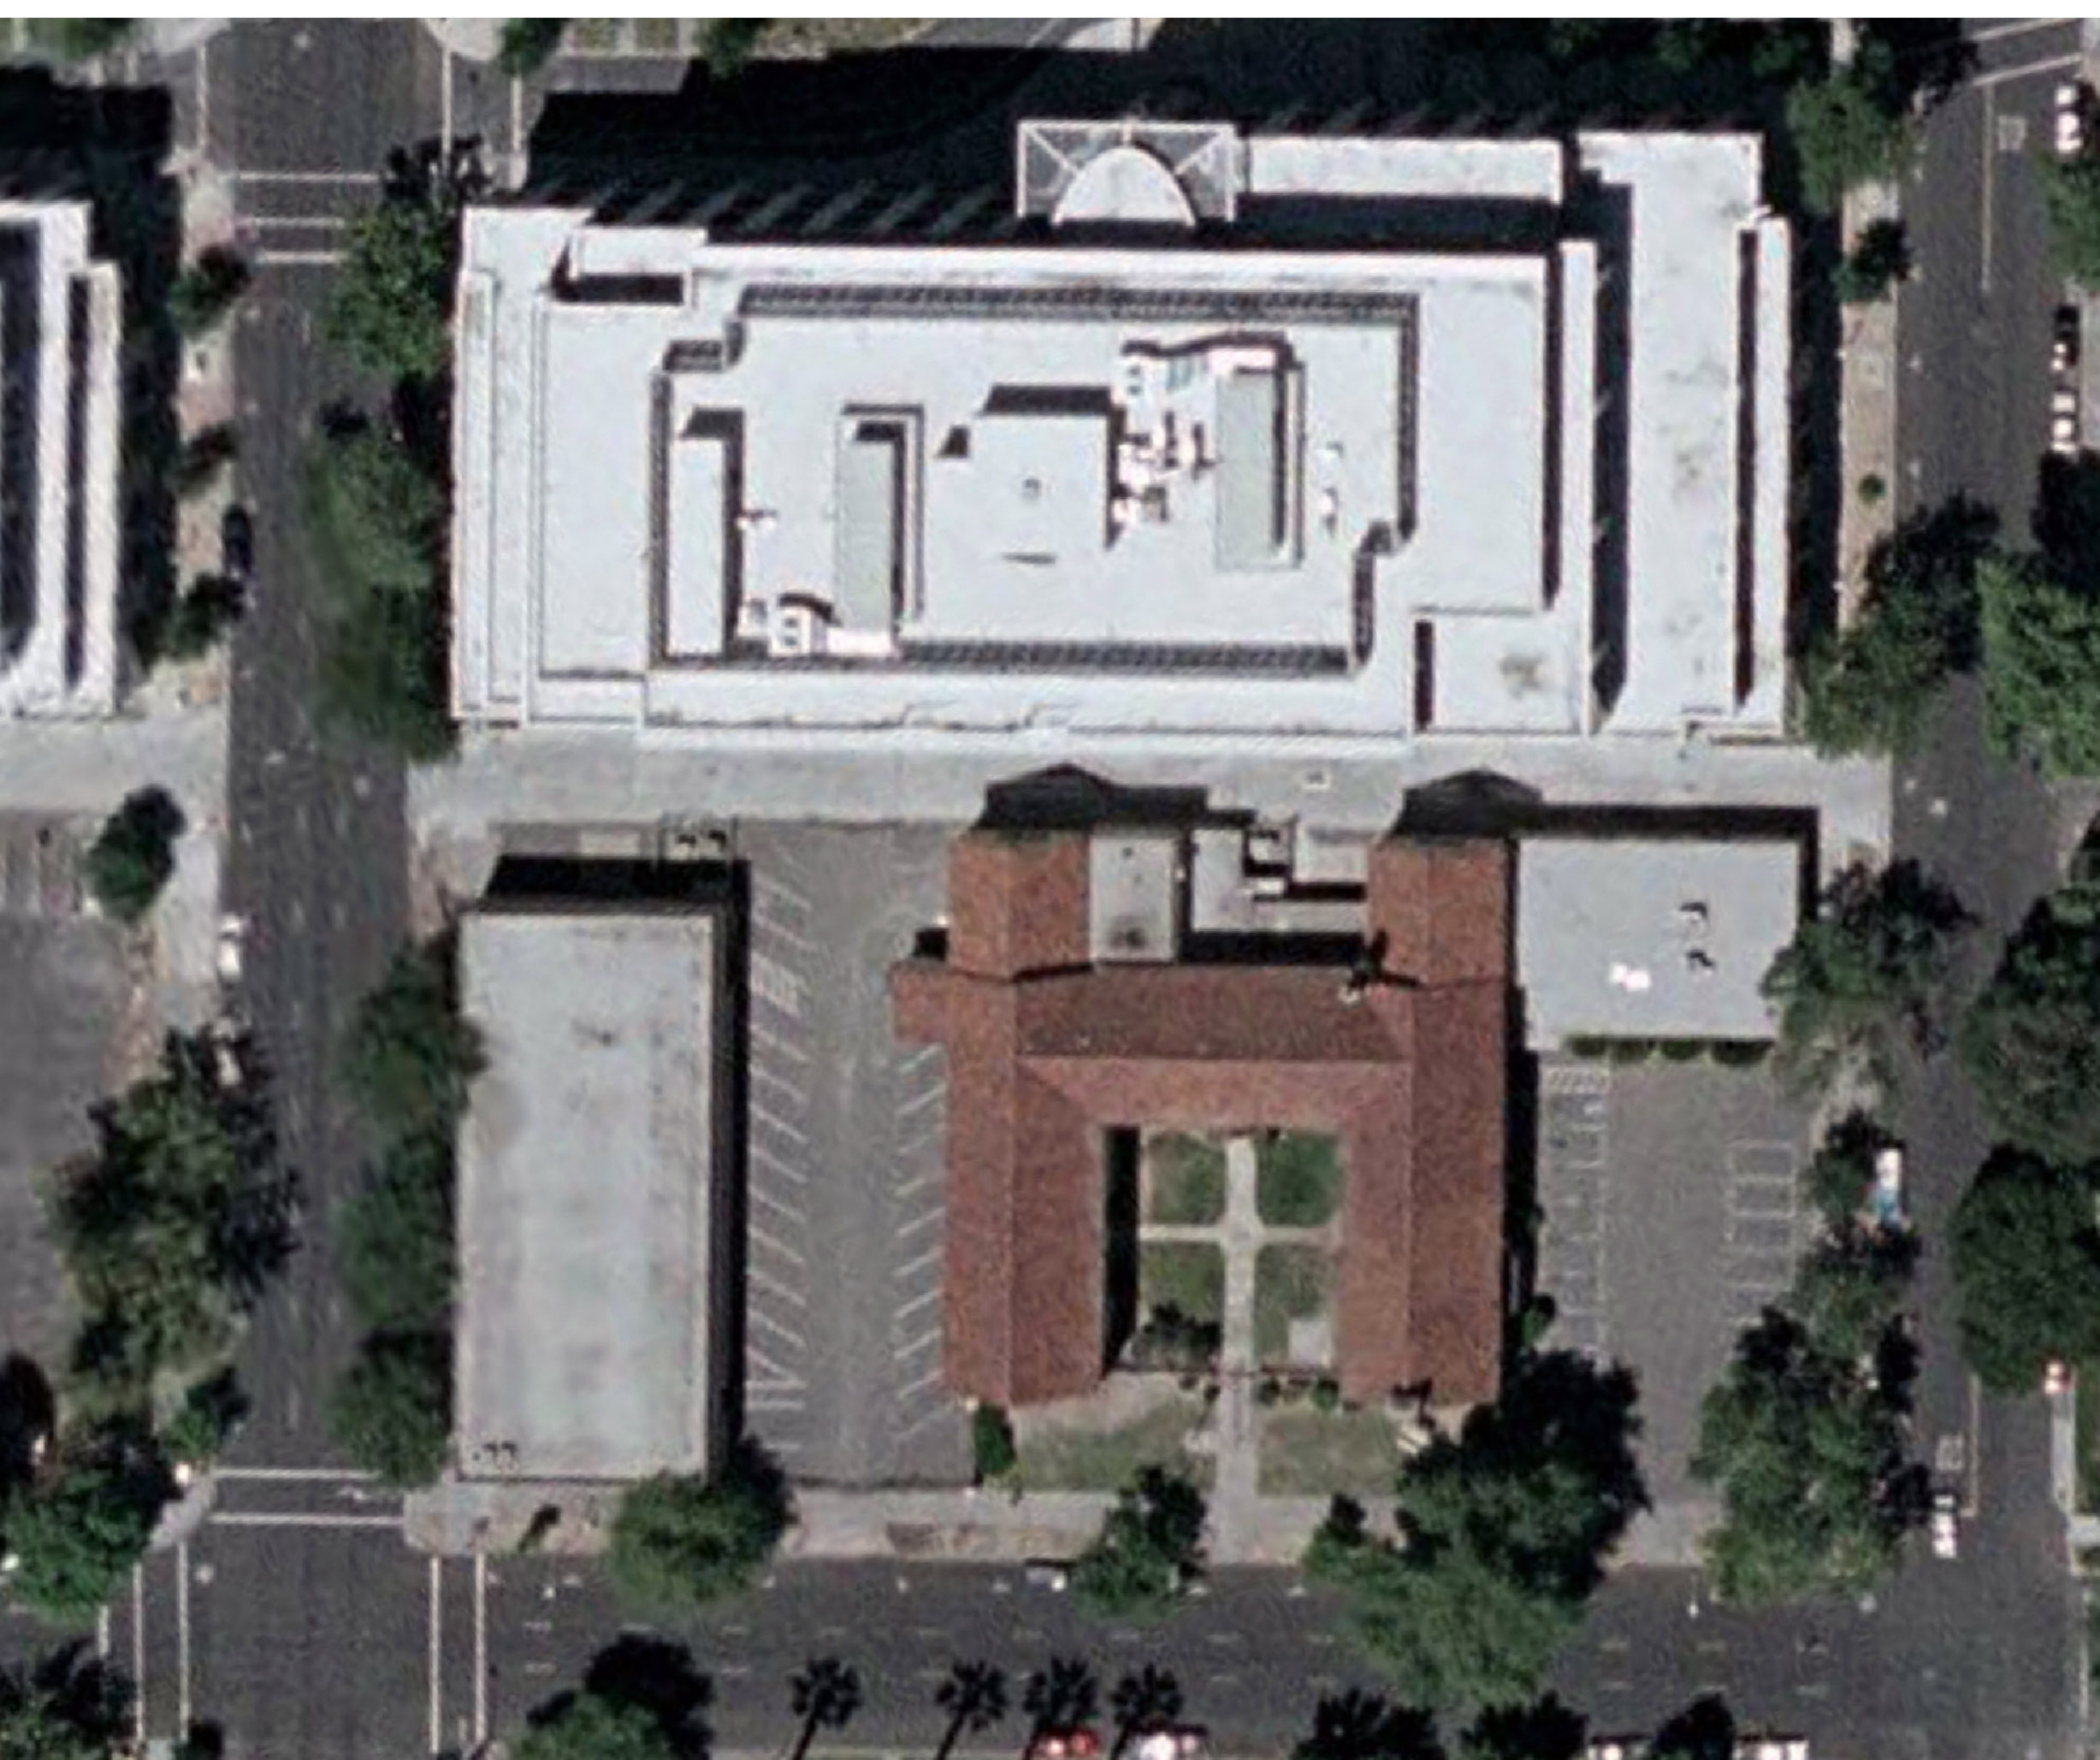
# SITE PLAN (W/ FIRST FLOOR)

16th and N St. Admin Complex

The 1.18 acre site is located in the central development corridor with a new state office building west of 16th Street. There is minimum parking available for visitors and the current two story brick and two story CMU, bunker type facilities use up 48% of the site area leaving very little space available for student use except for grassed and landscaped quadrangles. The remainder of the site is paved and/or street right-of-way. The overall condition of the site is fair to good, with asphalt areas on the east side in the worst condition.

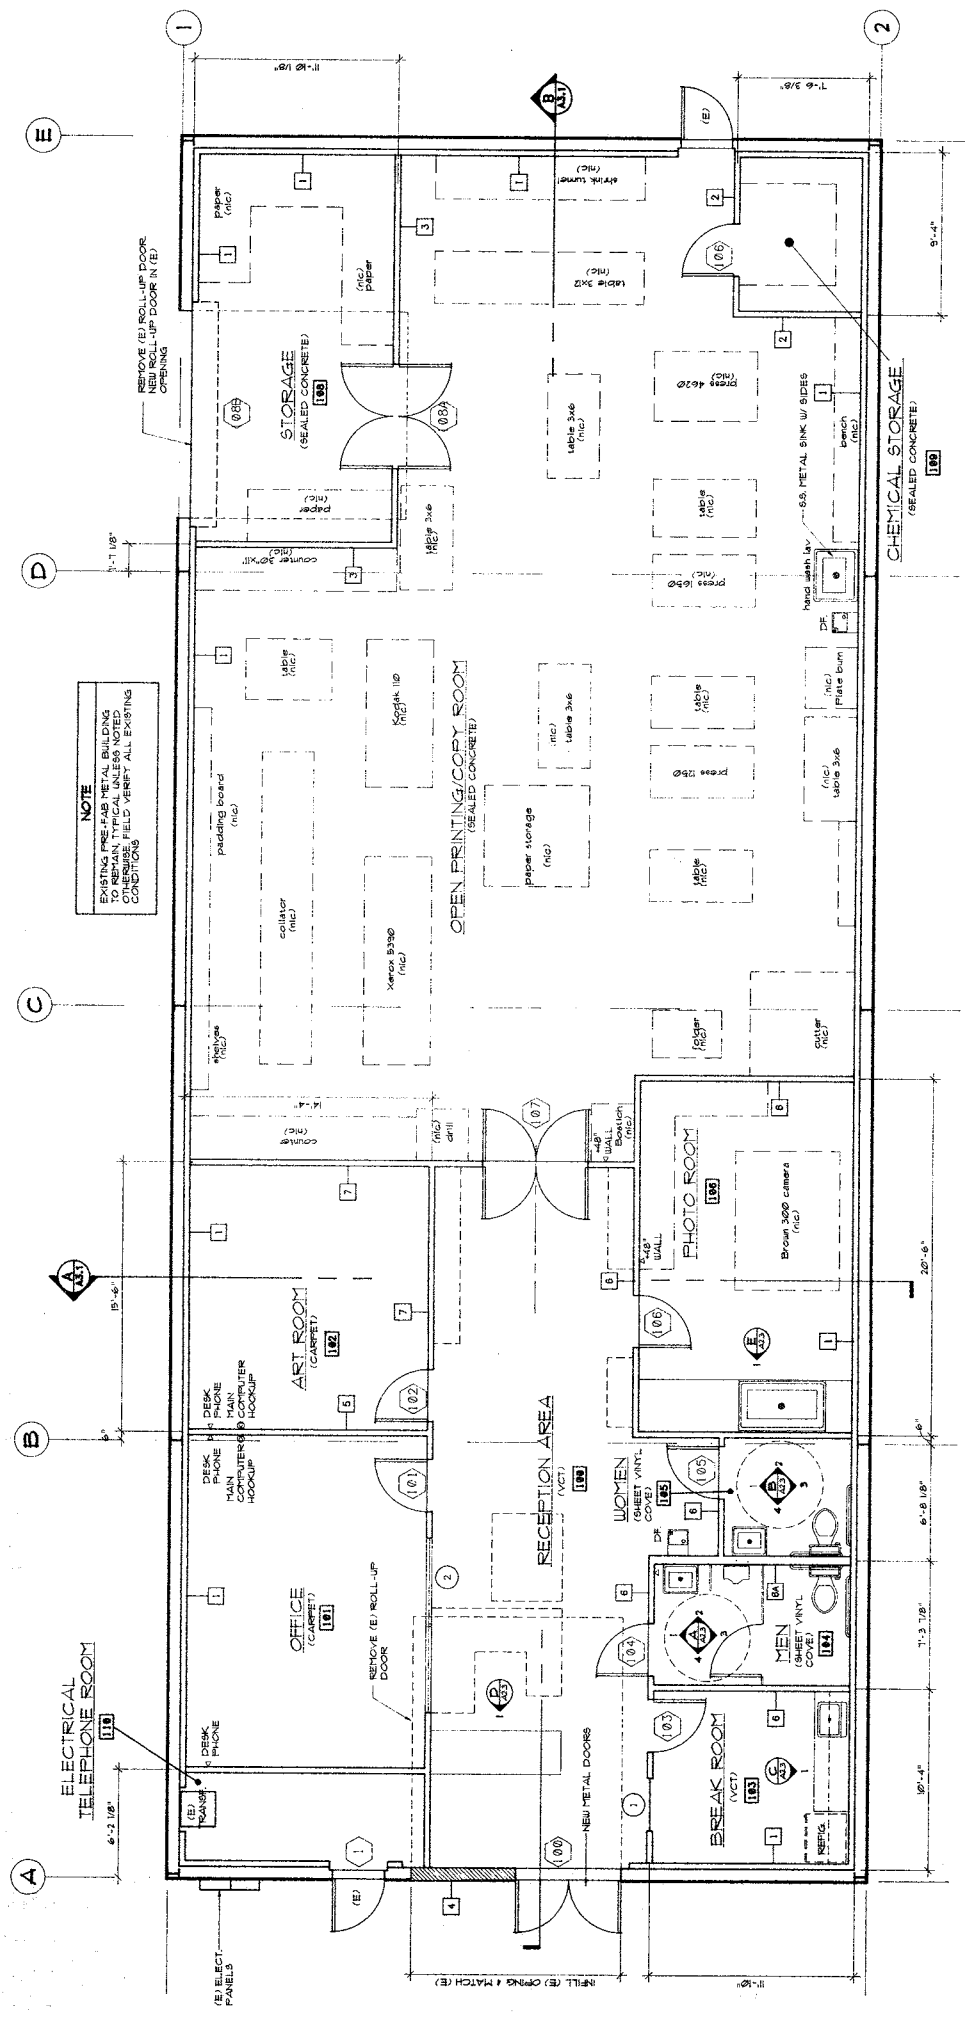
**FLOOR PLAN / PRINT SHOP**

**NOTE**  
 EXISTING PRE-CAST METAL BUILDING  
 OTHERWISE, FIELD VERIFY ALL EXISTING  
 CONDITIONS
